GOLETA SANITARY DISTRICT
NPDES MONITORING PROGRAM
2022 ANNUAL REPORT

Submitted: January 30, 2023

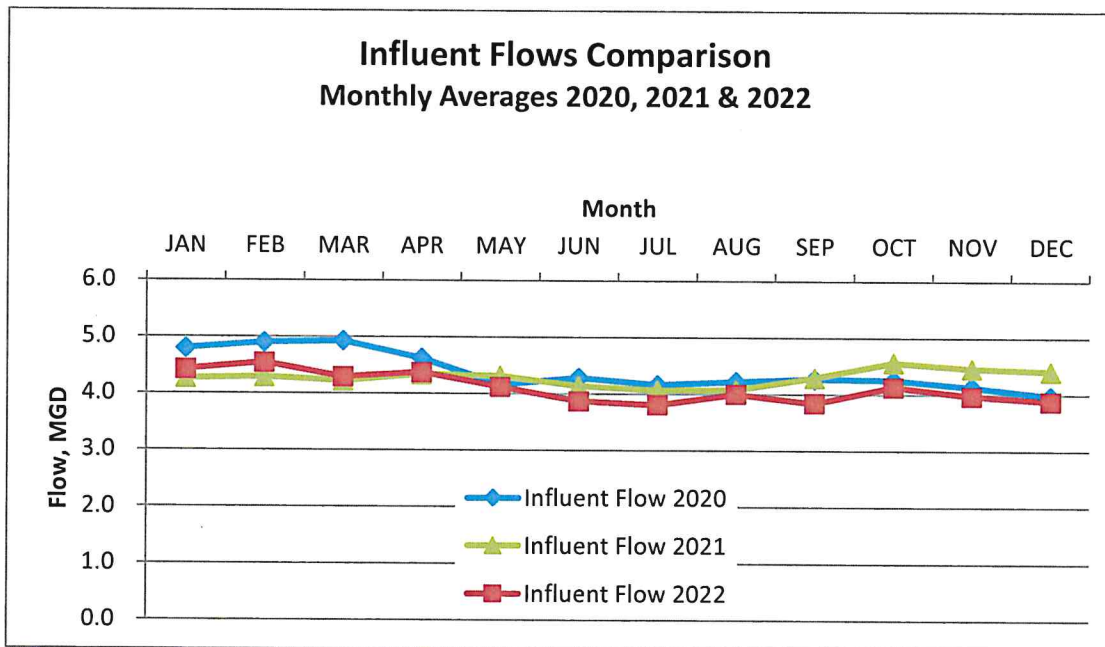
Figure 2-1. Influent Flows Monthly Average Comparison for 2020, 2021 and 2022

Overall, the average monthly influent flows for 2022 had minor seasonal variations throughout the year, fluctuating from a low of 3.80 MGD in July to a high of 4.54 MGD in February. The decrease in average influent flow observed at the plant is likely due to water conservation implemented by residents in response to the drought conditions. See Figure 2-1 for a visual flow comparison.

The highest flows into the plant during 2022 occurred during the beginning of the year, and may be associated with the rain events that occurred in January and March.

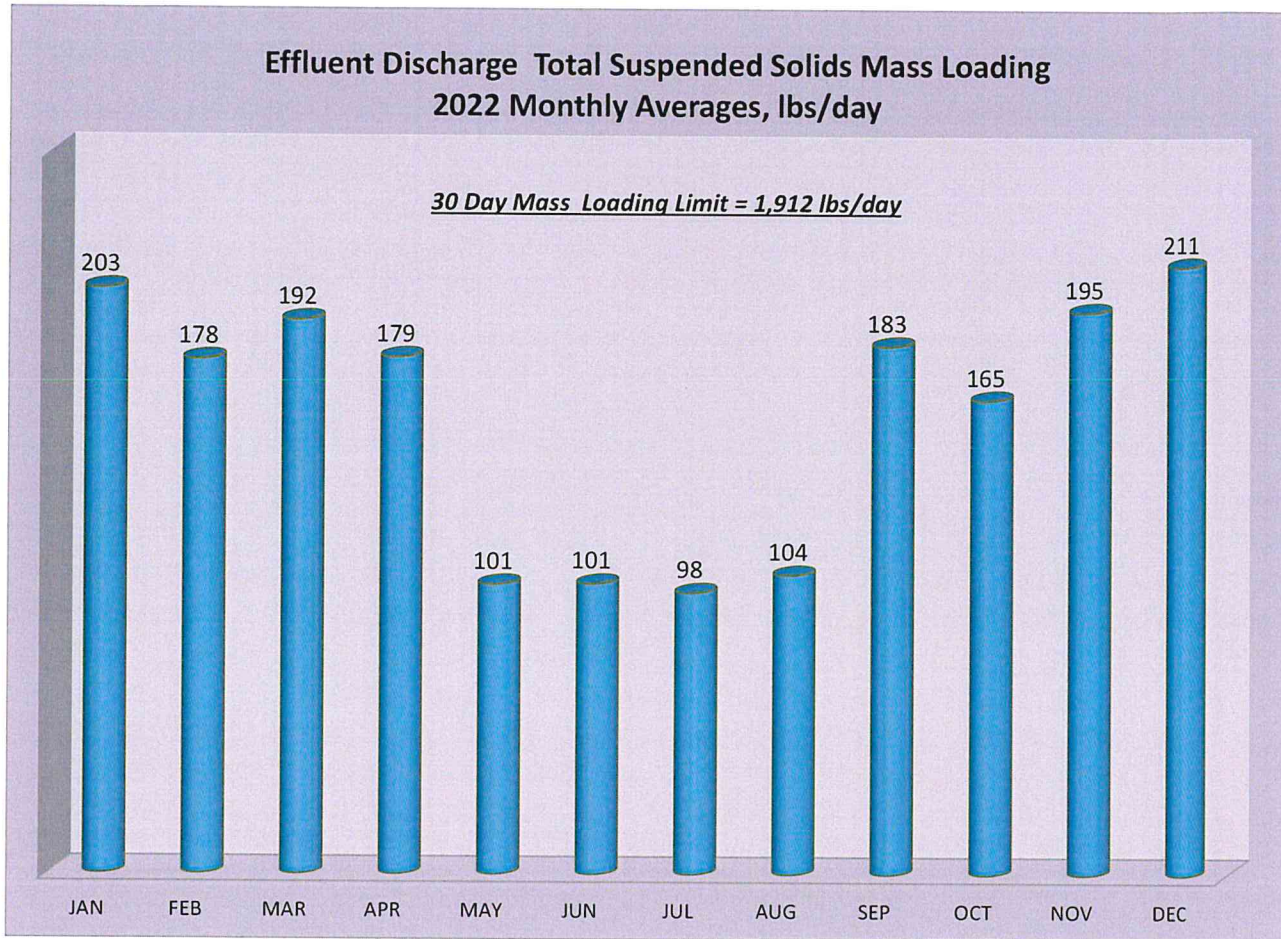
Figure 2-4. Effluent Discharge Total Suspended Solids Mass Loading, 2022 Monthly Averages, lbs/day

Average monthly suspended solids mass loading rates for 2022 are represented graphically in Figure 2-4. The mass emission limit is based on average dry weather flow (ADWF) and is a limit applied to dry weather flows (DWF). There is no limit for mass emissions on wet weather flows.

The maximum average monthly mass emission loading for 2022 occurred in December at a high of 211 lbs/day, which is approximately 11 percent of the permitted monthly 30-day average limit of 1,912 lbs/day. Loading rates were well below the discharge limits throughout the year.

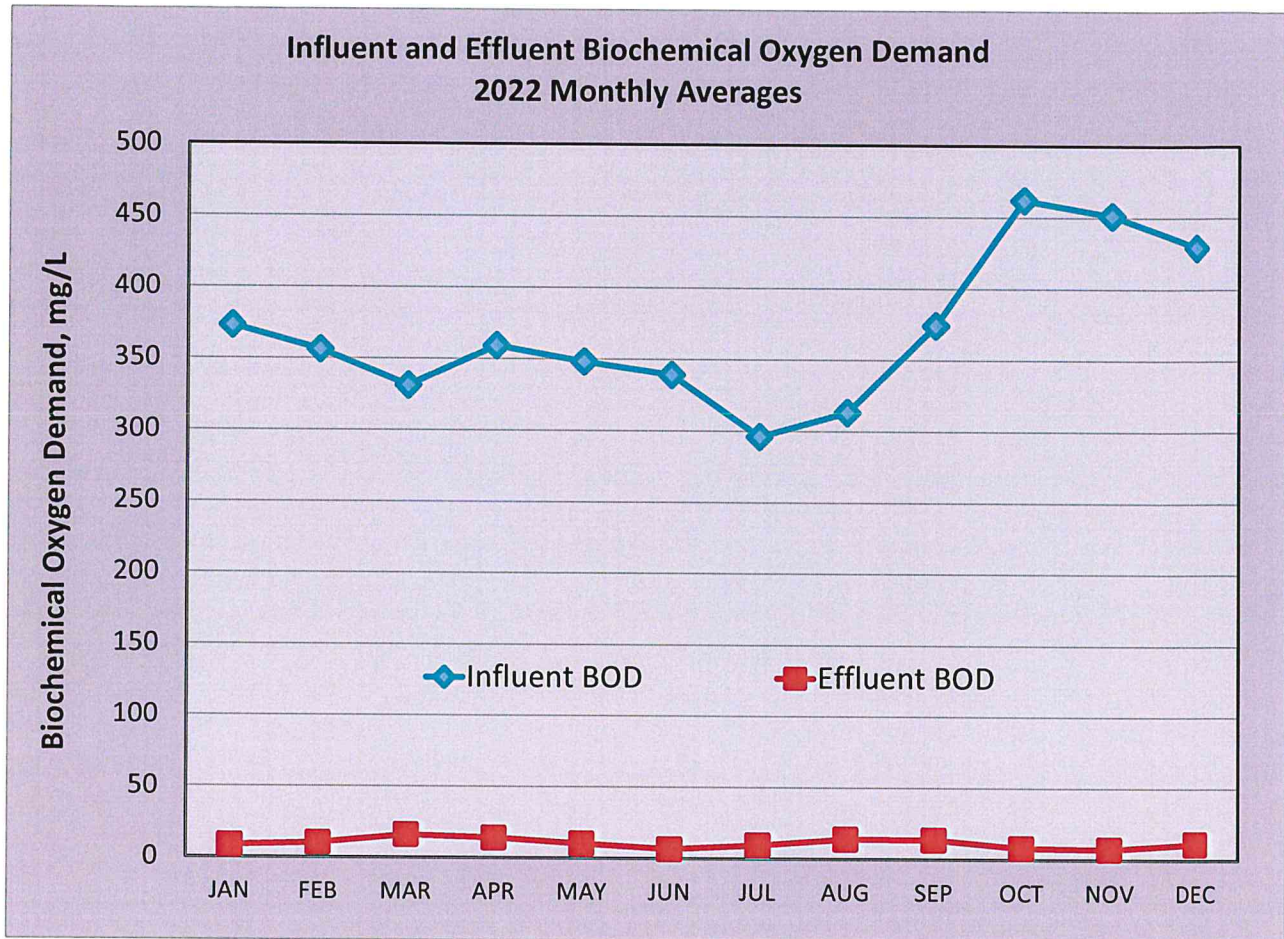
Figure 2-5. Influent and Effluent Biochemical Oxygen Demand 2022 Monthly Averages

During 2022 influent BOD averaged 369 mg/L showing an increase of 5% from the annual influent average of 359 for 2021. The influent BOD varied throughout the year, ranging from a monthly average low of 296 mg/L in July to a high of 462 mg/L in October.

Variations in the monthly average final effluent BOD concentration were observed throughout the year with the annual average of 10.6 mg/L and the range extending from a low of 6.3 in June to a high of 15.8 in March, (Table 2-1). The difference between influent and effluent BOD represents an average overall removal rate of 96.9 percent.

The NPDES R3-2017-0021 permit limits are an average of 30 mg/L and weekly average of 45 mg/L. All BOD NPDES limitations were achieved throughout the year.

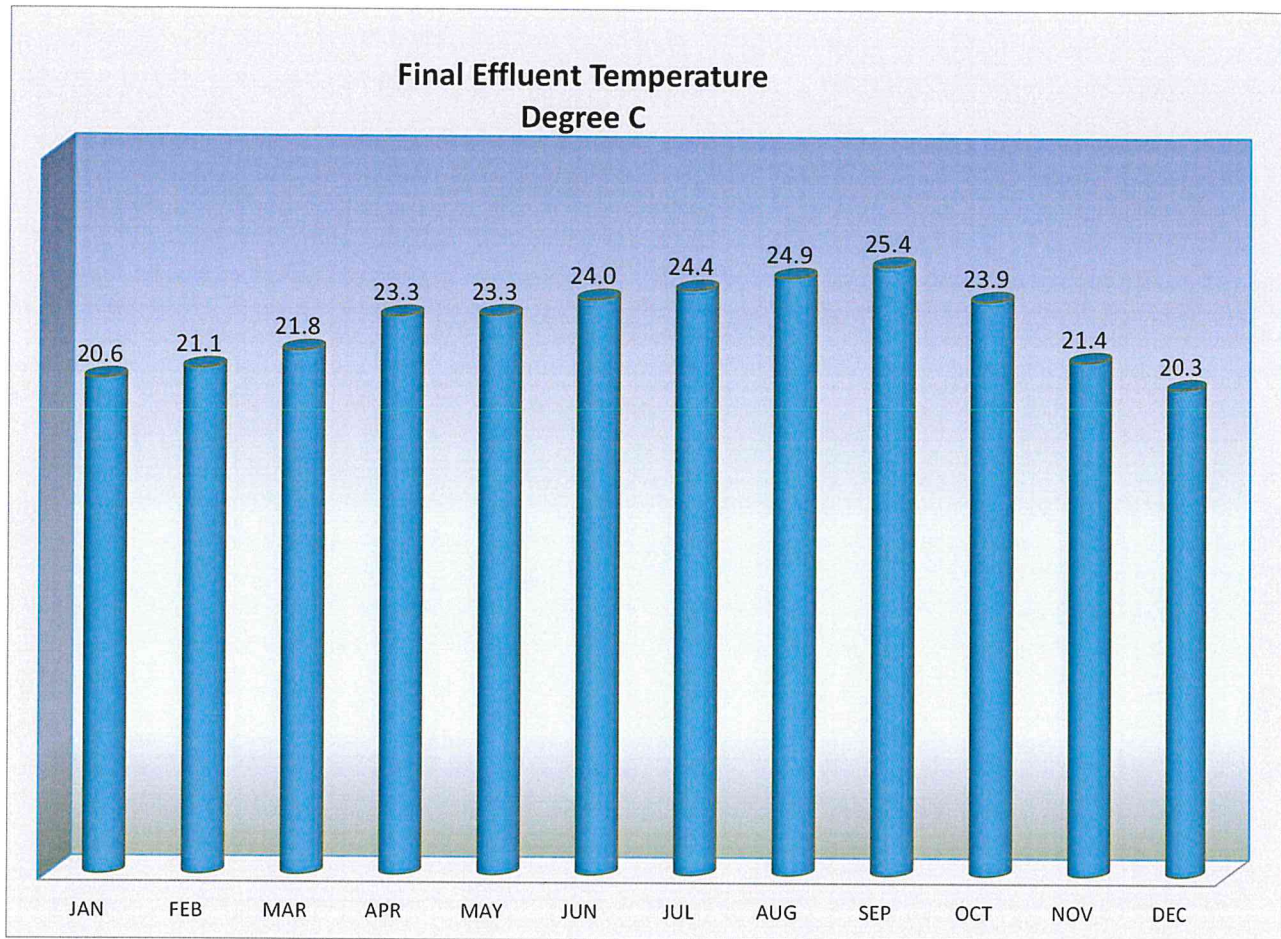
Figure 2-8. Effluent Discharge Temperature 2022 Monthly Averages

Effluent temperature was sampled five days per week throughout 2022. The data reflect a typical response to seasonal changes (Figure 2-8). The coolest temperatures occurred during December with average monthly temperatures of 20.3 °C. A warming trend continued throughout the summer and fall months to reach a monthly averaged high of 25.4 °C in September. As expected, the year began with a cooling trend and ended with the coolest average temperature during the year.
