Facility Name: Goleta Sanitary District

GOLETA SANITARY DISTRICT
NPDES MONITORING PROGRAM
2023 ANNUAL REPORT

Submitted: January 31, 2024

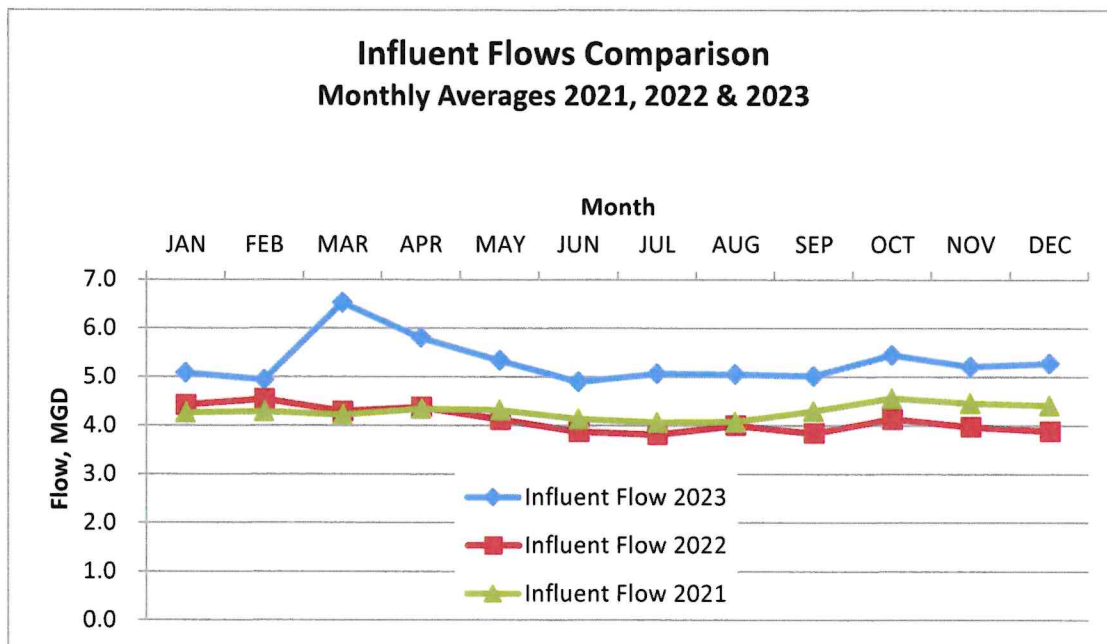
Figure 2-1. Influent Flows Monthly Average Comparison for 2021, 2022 and 2023

Overall, the average monthly influent flows for 2023 had minor seasonal variations throughout the year, fluctuating from a low of 4.89 MGD in June to a high of 6.52 MGD in March. The increase in average influent flow observed at the plant is likely due to the UCSB students returning to campus in person and the significant rain events compared to the last few years. See Figure 2-1 for a visual flow comparison.

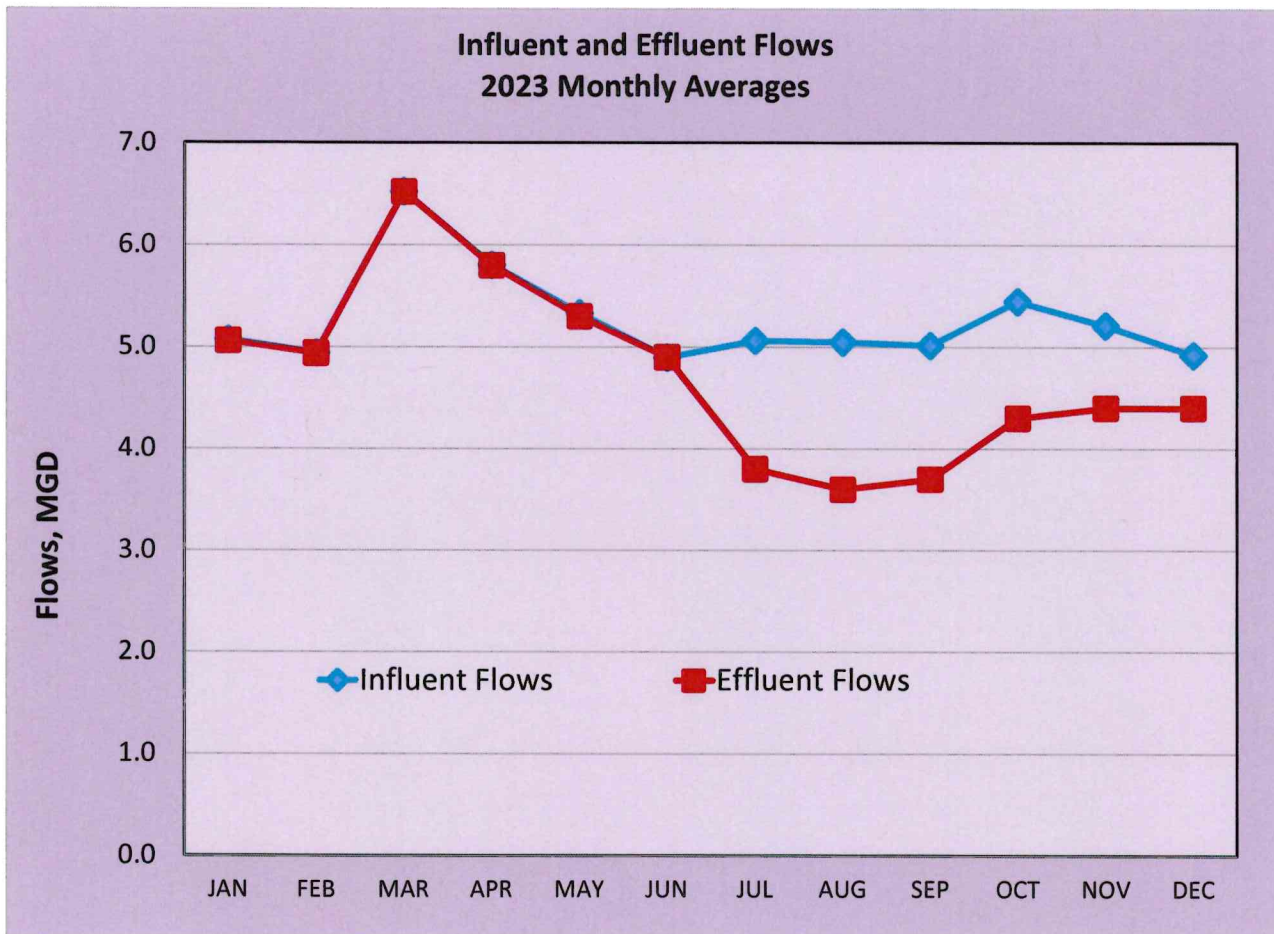
Figure 2-2. Influent and Effluent Flows 2023 Monthly Averages

Figure 2-2 shows the monthly average influent and effluent flows for 2023. Higher wastewater effluent flow generally occurs during the winter months when influent flow is also the highest and recycling is minimal. However, during 2023 the reclamation facility was not operated until July. The most important factor contributing to fluctuations in the effluent flow is the amount of wastewater that is processed into reclaimed water and used for irrigation.

The lowest effluent flow occurred during August when the average amount of flow discharged to the Pacific Ocean dropped to 3.6 MGD. The variations in the monthly average effluent flow seen in 2023 fluctuated from a low of 3.60 MGD in August, when the daily production of reclaimed water averaged 1.19 MGD for the month to a high of 6.52 MGD during March when the reclaimed facility was off line and a significant rain event occurred.

Figure 2-2 depicts the influent and effluent flows and Table 2-1 shows the actual monthly flow average values.

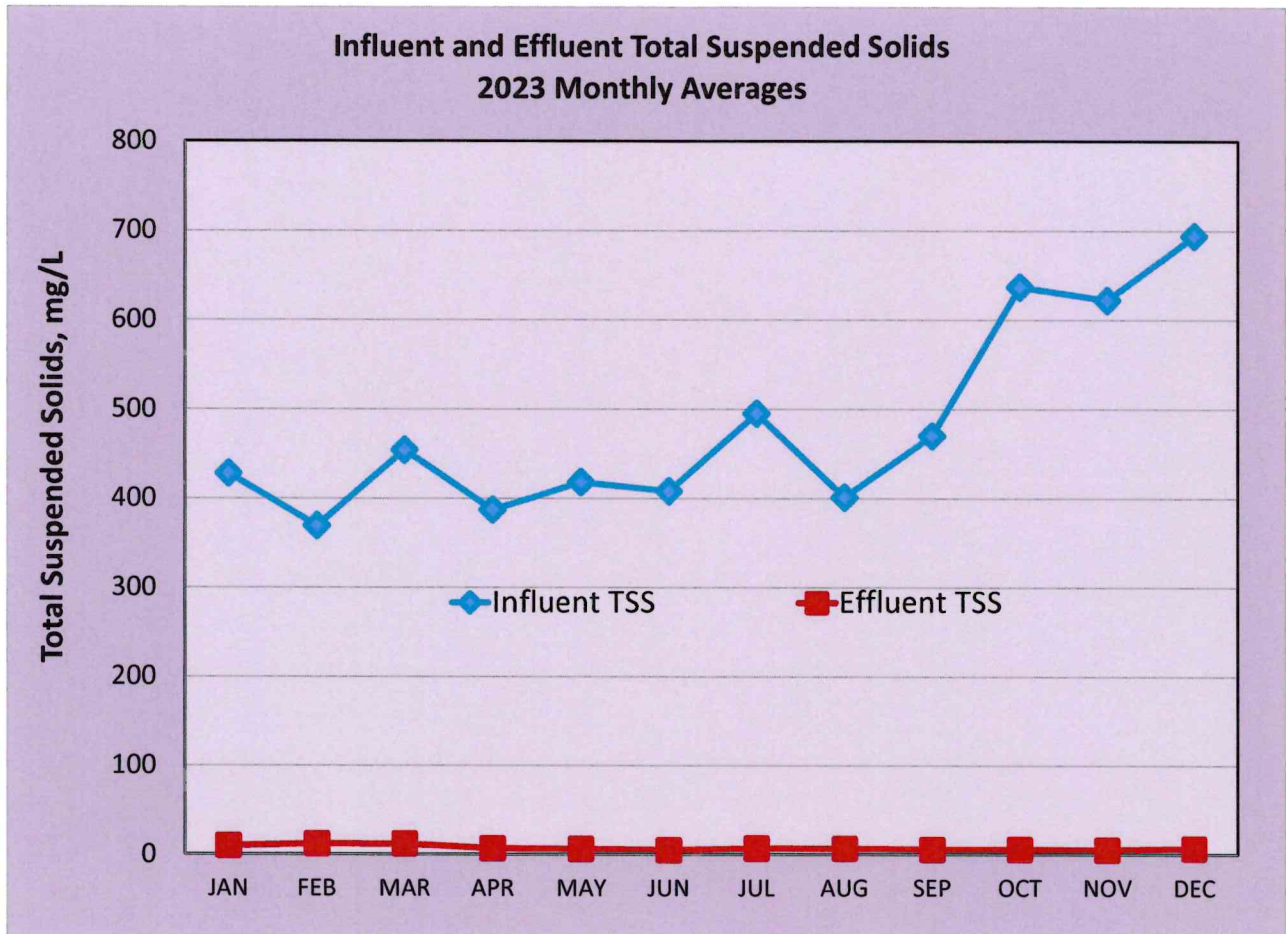
Figure 2-3. Influent and Effluent Total Suspended Solids 2023 Monthly Averages

Influent and effluent suspended solids were measured five days per week on 24-hour composite samples. The effectiveness of the treatment plant in removing suspended solids is demonstrated by the variation of influent solids versus the low-level and consistent output of effluent solids (see Figure 2-3). Influent suspended solids concentrations averaged 482 mg/L for the year showing an increase of about 11% from the 2022 annual average of 435 mg/L. Figure 2-3 shows a fluctuation in concentration of suspended solids that occurred during the year. The treatment process reduced the concentration of total suspended solids in the effluent to an annual average of 7.4 mg/L which is an increase from the 5.9 mg/L average of 2022.

All effluent 30-day monthly averages were well below the 30-mg/L monthly average limitation. Overall removal efficiency for the year was an average of 98.3 percent, see Table 2-1.

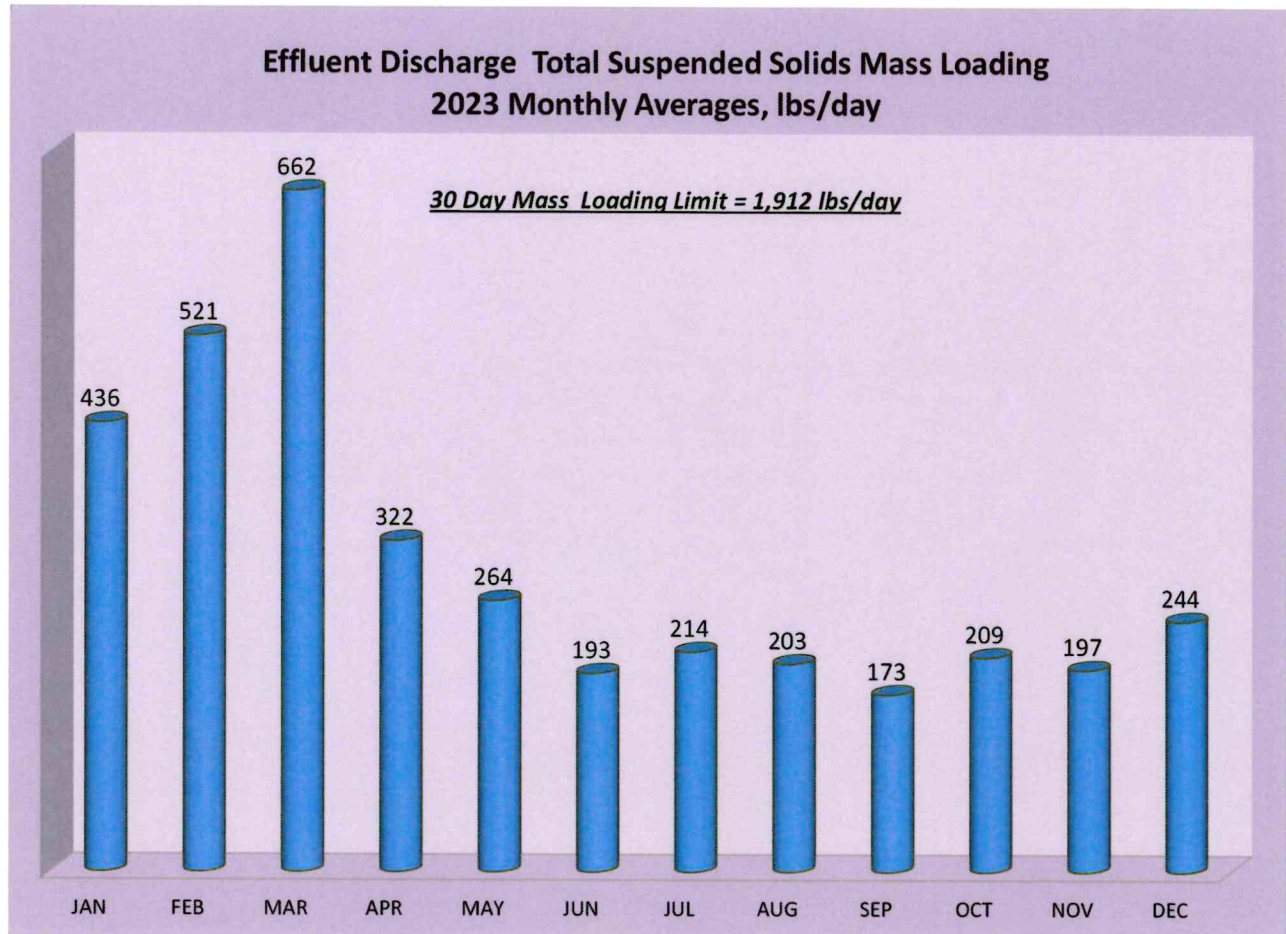
Figure 2-4. Effluent Discharge Total Suspended Solids Mass Loading, 2023 Monthly Averages, lbs/day

Average monthly suspended solids mass loading rates for 2023 are represented graphically in Figure 2-4. The mass emission limit is based on average dry weather flow (ADWF) and is a limit applied to dry weather flows (DWF). There is no limit for mass emissions on wet weather flows.

The maximum average monthly mass emission loading for 2023 occurred in March at a high of 662 lbs/day, which is approximately 35 percent of the permitted monthly 30-day average limit of 1,912 lbs/day. Loading rates were well below the discharge limits throughout the year.

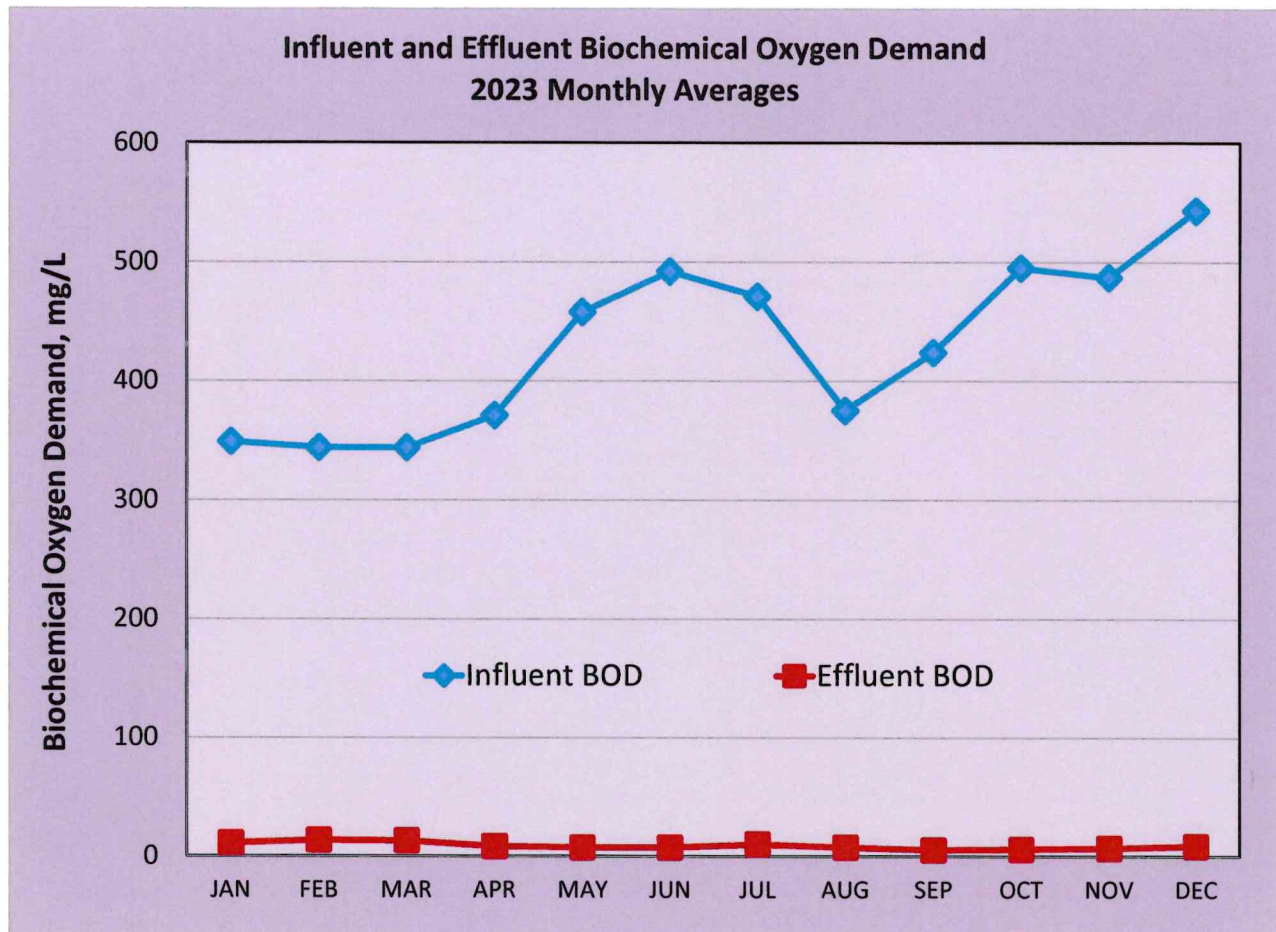
Figure 2-5. Influent and Effluent Biochemical Oxygen Demand 2023 Monthly Averages

During 2023 influent BOD averaged 429 mg/L showing an increase of 16% from the annual influent average of 369 for 2022. The influent BOD varied throughout the year, ranging from a monthly average low of 344 mg/L in January and February to a high of 543 mg/L in December. Variations in the monthly average final effluent BOD concentration were observed throughout the year with the annual average of 8.7 mg/L and the range extending from a low of 5.4 in September to a high of 13.5 in February, (Table 2-1). The difference between influent and effluent BOD represents an average overall removal rate of 97.8 percent.

The NPDES R3-2017-0021 permit limits are an average of 30 mg/L and weekly average of 45 mg/L. All BOD NPDES limitations were achieved throughout the year.

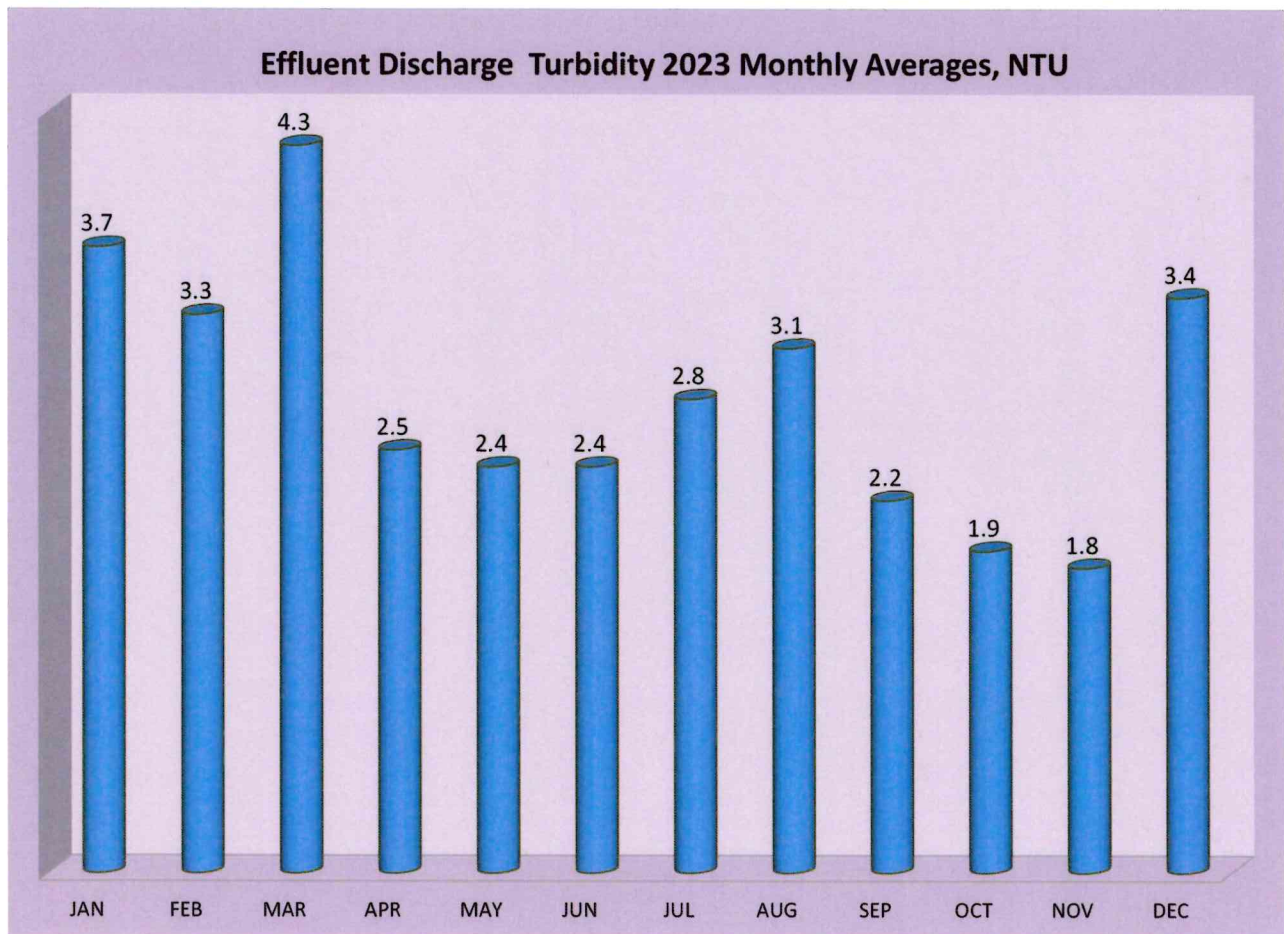
Figure 2-6. Effluent Discharge Turbidity 2023 Monthly Averages, NTU

Effluent turbidity was monitored five days per week. The permit limitations for effluent turbidity consists of a monthly average of 75 Nephelometric Turbidity Units (NTU), a weekly average of 100 NTU, and a maximum at any time limitation of 225 NTU. Effluent turbidity data are shown graphically in Figure 2-6. The maximum value at any time, 10.4 NTU, occurred on January 10th which was still well below the effluent limits. Monthly averages ranged from a low of 1.8 NTU to a high of 4.3 NTU. All values were significantly below their respective permit limitations.

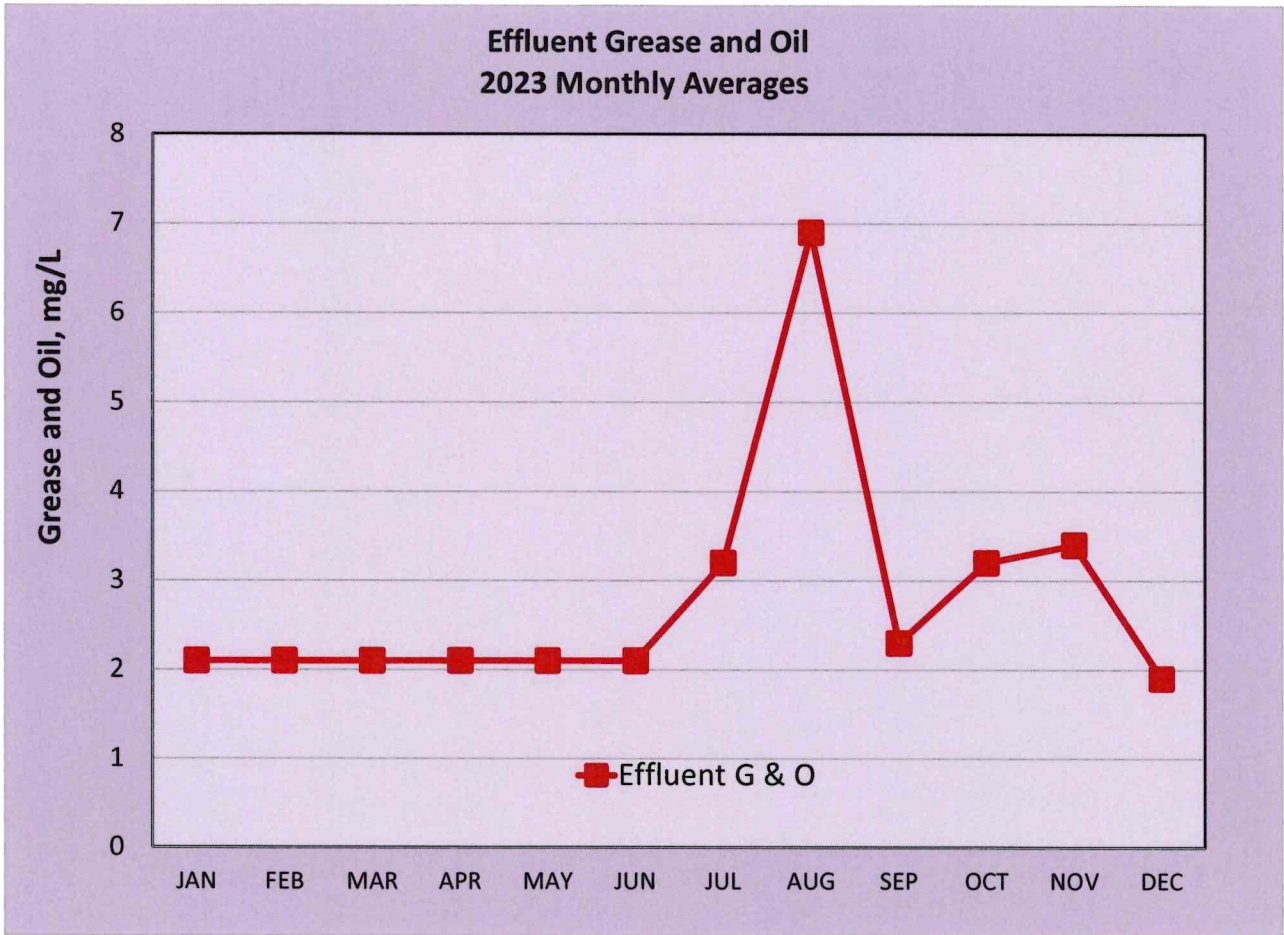
Figure 2-7. Effluent Grease and Oil 2023 Monthly Averages

Effluent oil and grease were monitored weekly. Monthly average results are shown graphically in Figure 2-7. Prior to August 2007 Freon was the solvent used in the standard method to extract oil and greases from water samples. According to EPA regulations, in August 2007 the GSD laboratory ceased using Freon as the extraction solvent and began using hexane as the required solvent. The District continued to use the liquid-liquid extraction method, the only change at this time was the solvent. In December 2010, the GSD laboratory began analyzing for oil and grease using the approved standard solid phase extraction (SPE) EPA 1664 method. However, oil and grease samples were also subcontracted to OEC during the year. The current permit, R3-2017-0021, eliminated the influent oil and grease monitoring requirement.

Effluent grease and oil concentrations were low during 2023. All monthly, weekly, and maximum permit limits were met. Mass emissions values ranged from a monthly average low of 80 lbs/day in December to a high of 211 lbs/day in August. Both are well below the permit limitation of 1,590 lbs/day. Monthly average oil and grease concentrations in the effluent ranged from 2.1 mg/L to 6.9 mg/L. See Table 2-2 for a visual representation of the monthly average results. All permit limitations for effluent oil and grease were met during 2023.

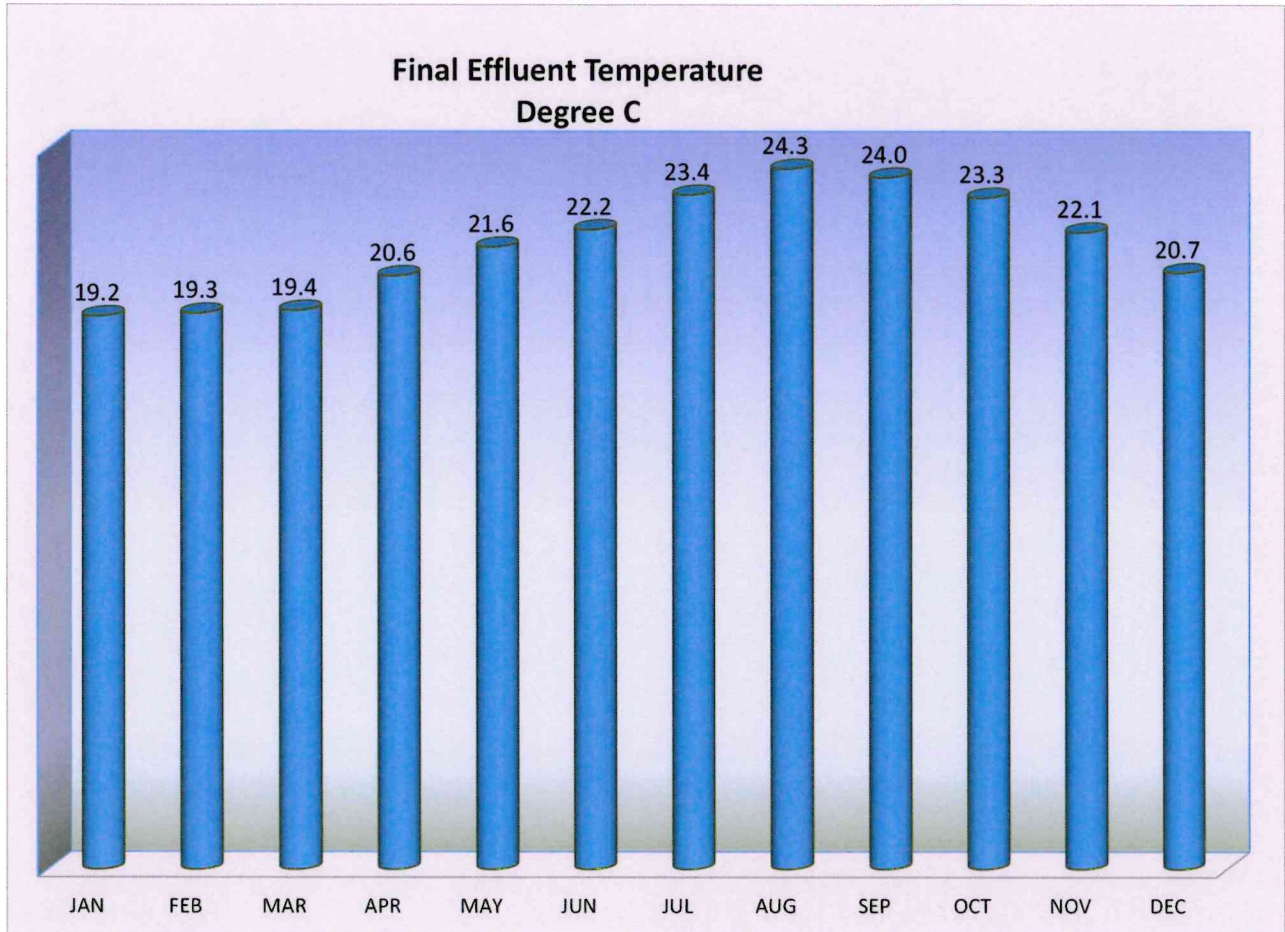
Figure 2-8. Effluent Discharge Temperature 2023 Monthly Averages

Effluent temperature was sampled five days per week throughout 2023. The data reflect a typical response to seasonal changes (Figure 2-8). The coolest temperatures occurred during January with average monthly temperatures of 19.2 ° C. A warming trend continued throughout the summer and fall months to reach a monthly averaged high of 24.3 ° C in August. The year began with the coolest average temperatures and ended with a cooling trend.
