**GOLETA SANITARY DISTRICT**  
**NPDES MONITORING PROGRAM**  
**2024 ANNUAL REPORT**

*Submitted: January , 2025*

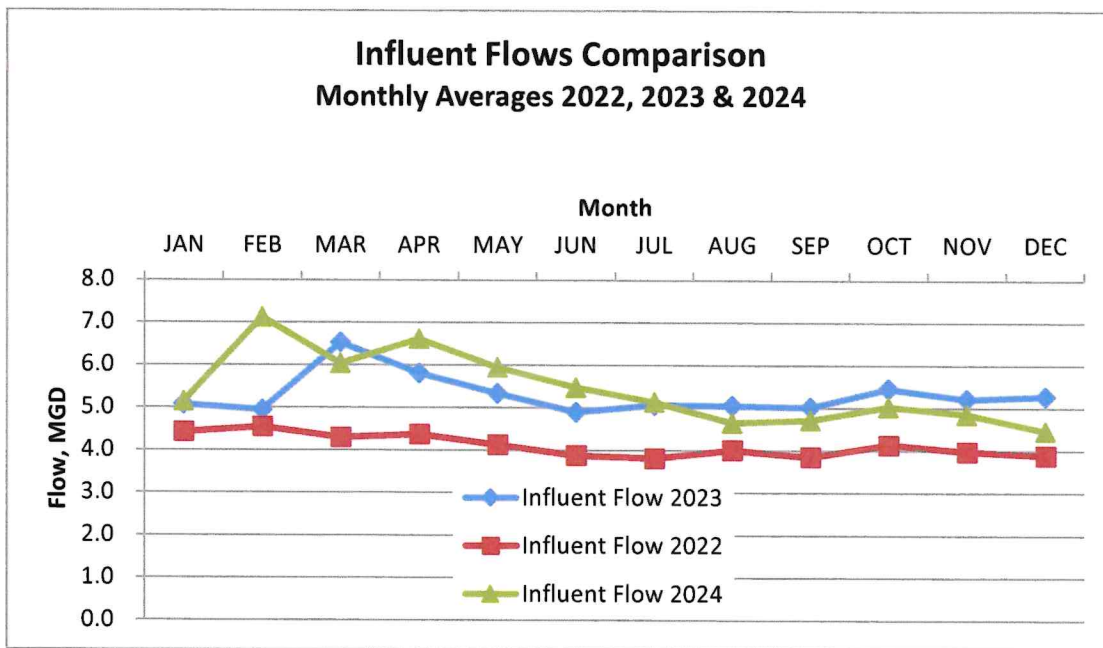
**Figure 2-1. Influent Flows Monthly Average Comparison for 2022, 2023 and 2024**

Overall, the average monthly influent flows for 2024 had minor seasonal variations throughout the year, fluctuating from a low of 4.46 MGD in December to a high of 7.12 MGD in February. See Figure 2-1 for a visual flow comparison.

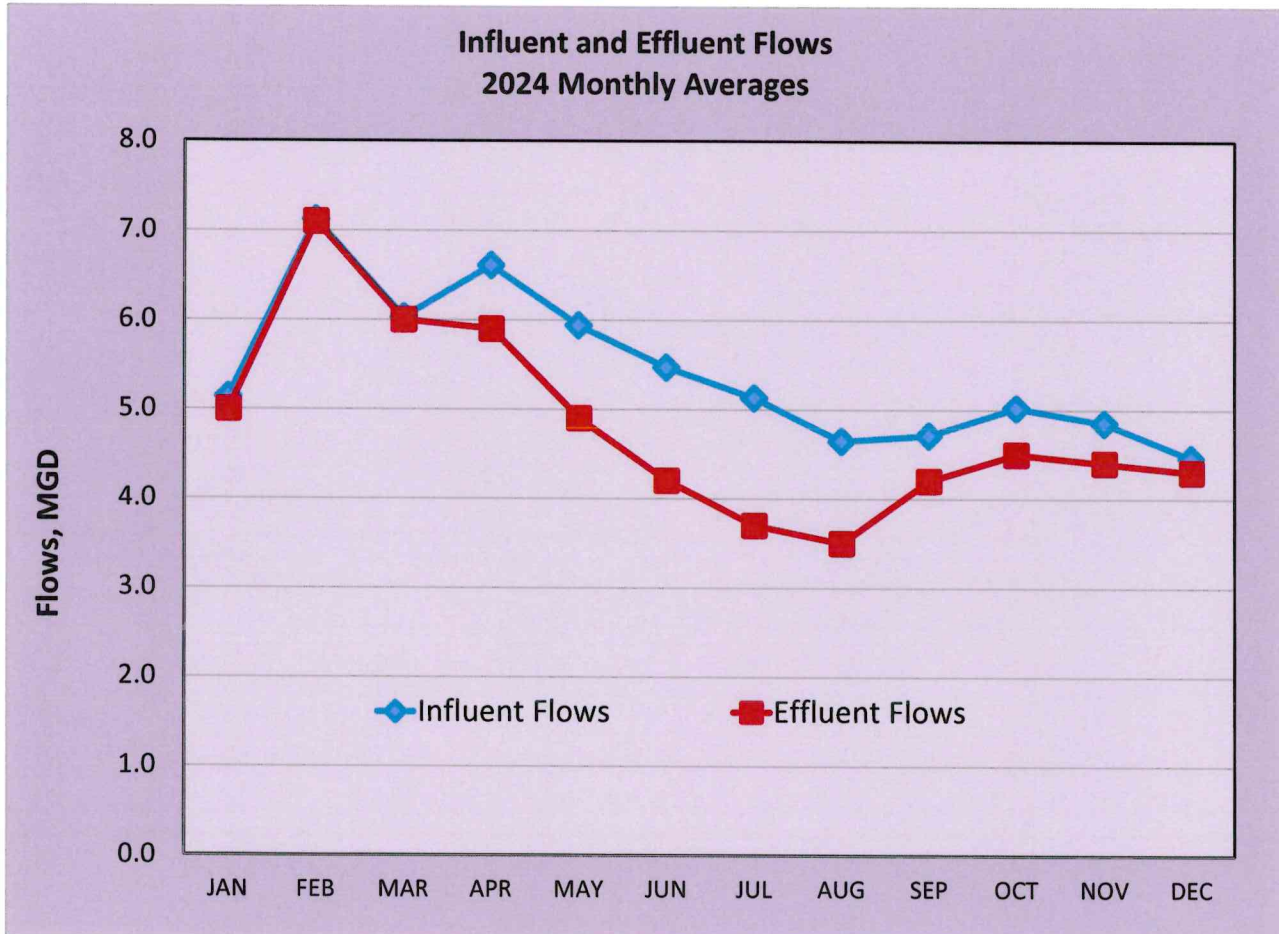
**Figure 2-2. Influent and Effluent Flows 2024 Monthly Averages**

Figure 2-2 shows the monthly average influent and effluent flows for 2024. Higher wastewater effluent flow generally occurs during the winter months when influent flow is also the highest and recycling is minimal. However, during 2024 the reclamation facility was not operated during February and March. The most important factor contributing to fluctuations in the effluent flow is the amount of wastewater that is processed into reclaimed water and used for irrigation.

The lowest effluent flow occurred during August when the average amount of flow discharged to the Pacific Ocean dropped to 3.5 MGD. The variations in the monthly average effluent flow seen in 2024 fluctuated from a low of 3.50 MGD in August, when the daily production of reclaimed water averaged 1.51 MGD for the month to a high of 7.10 MGD

during February when the reclaimed facility was off line and a significant rain event occurred. Figure 2-2 depicts the influent and effluent flows and Table 2-1 shows the actual monthly flow average values.

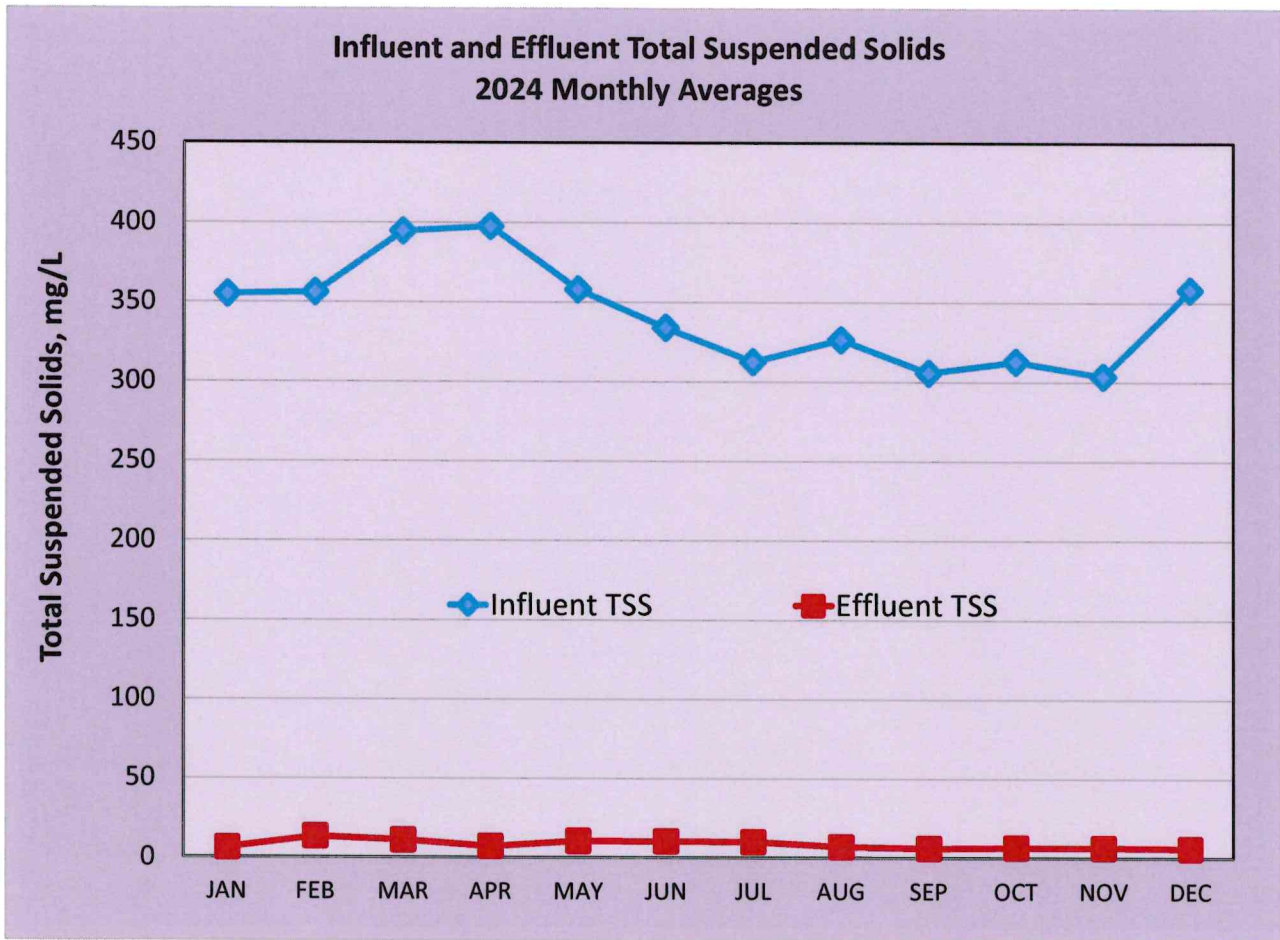
Figure 2-3. Influent and Effluent Total Suspended Solids 2024 Monthly Averages

Influent and effluent suspended solids were measured five days per week on 24-hour composite samples. The effectiveness of the treatment plant in removing suspended solids is demonstrated by the variation of influent solids versus the low-level and consistent output of effluent solids (see Figure 2-3). Influent suspended solids concentrations averaged 434 mg/L for the year showing a decrease of about 10% from the 2023 annual average of 482 mg/L. Figure 2-3 shows a fluctuation in concentration of suspended solids that occurred during the year. The treatment process reduced the concentration of total suspended solids in the effluent to an annual average of 8.4 mg/L which is a minor increase from the 7.4 mg/L average of 2023.

All effluent 30-day monthly averages were well below the 30-mg/L monthly average limitation. Overall removal efficiency for the year was an average of 98.0 percent, see Table 2-1.

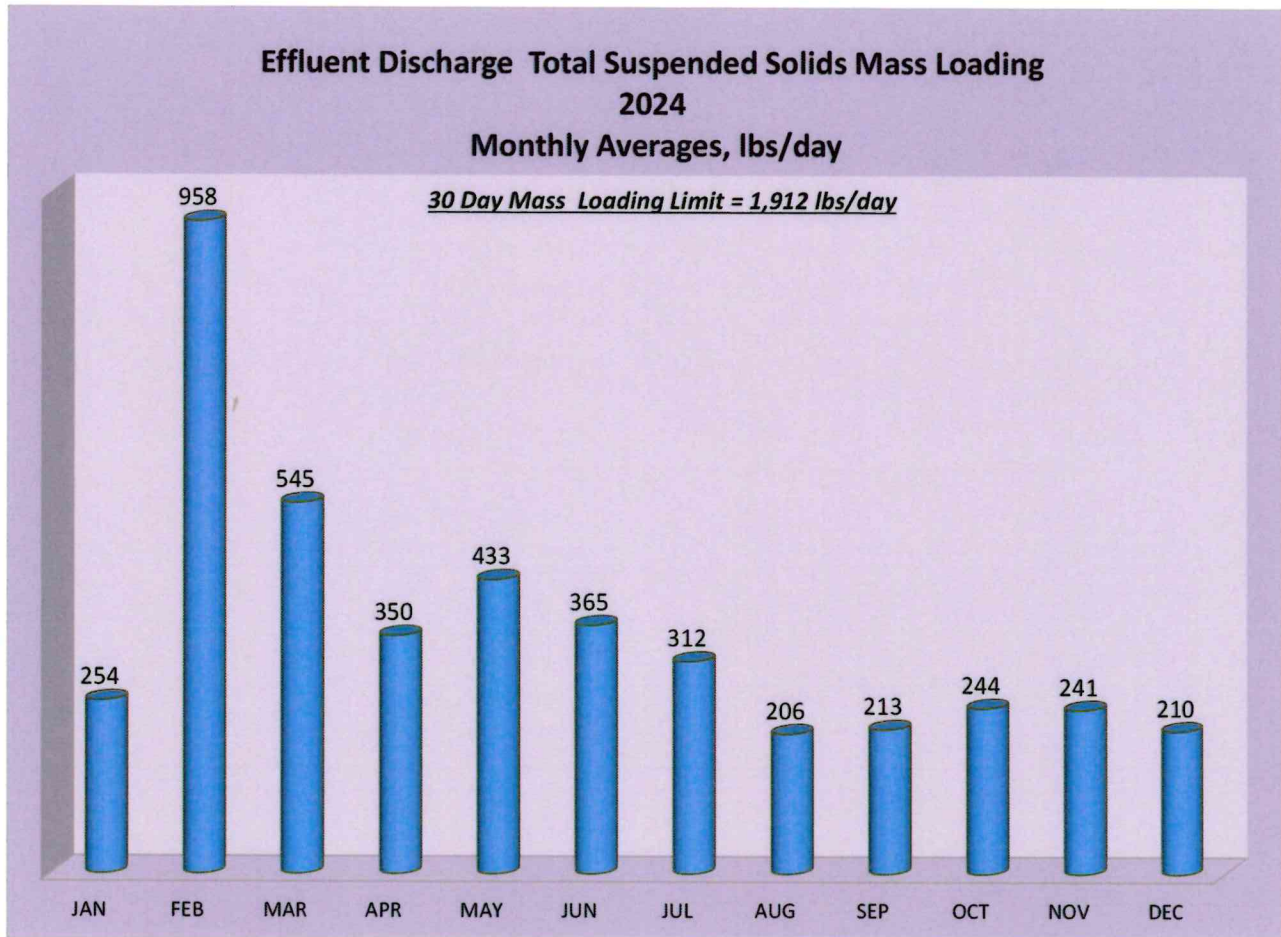
**Figure 2-4. Effluent Discharge Total Suspended Solids Mass Loading, 2024 Monthly Averages, lbs/day**

Average monthly suspended solids mass loading rates for 2024 are represented graphically in Figure 2-4. The mass emission limit is based on average dry weather flow (ADWF) and is a limit applied to dry weather flows (DWF). There is no limit for mass emissions on wet weather flows.

The maximum average monthly mass emission loading for 2024 occurred in February at a high of 958 lbs/day, which is approximately 50 percent of the permitted monthly 30-day average limit of 1,912 lbs/day. The average weekly limitation for suspended solids loading is 2,867 lbs/day. Loading rates were well below the discharge limits throughout the year with the exception of the first week in February when the weekly loading rate was 3,064 lbs/day.

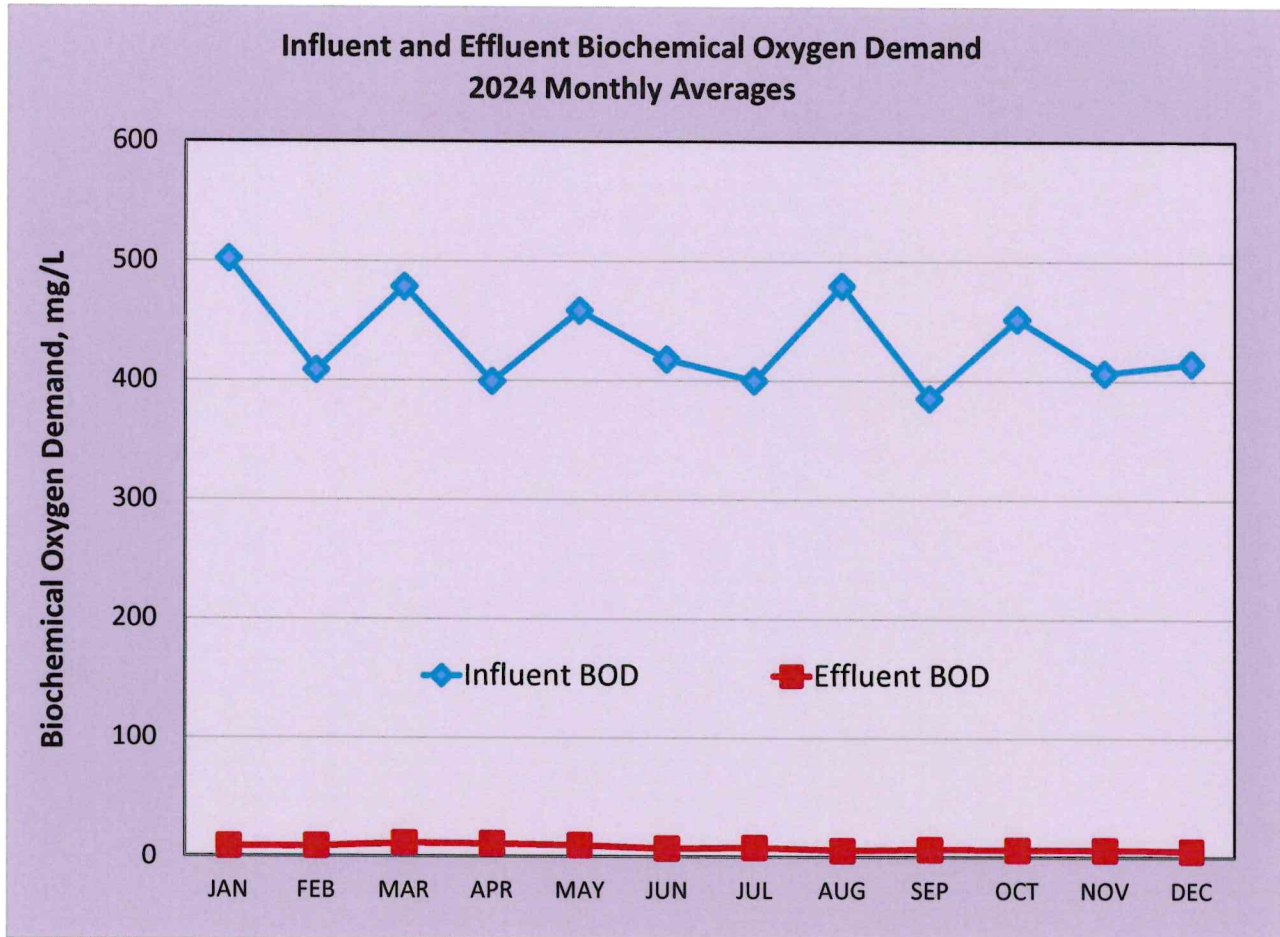
Figure 2-5. Influent and Effluent Biochemical Oxygen Demand 2024 Monthly Averages

During 2024 influent BOD averaged 343 mg/L showing a decrease of 20% from the annual influent average of 429 mg/L for 2023. The influent BOD varied throughout the year, ranging from a monthly average low of 303 mg/L in November to a high of 398 mg/L in April. Variations in the monthly average final effluent BOD concentration were observed throughout the year with the annual average of 7.7 mg/L and the range extending from a low of 5.2 mg/L in August to a high of 11.1 mg/L in March, (Table 2-1). The difference between influent and effluent BOD represents an average overall removal rate of 97.7 percent.

The NPDES R3-2017-0021 permit limits are an average of 30 mg/L and weekly average of 45 mg/L. All BOD NPDES limitations were achieved throughout the year.

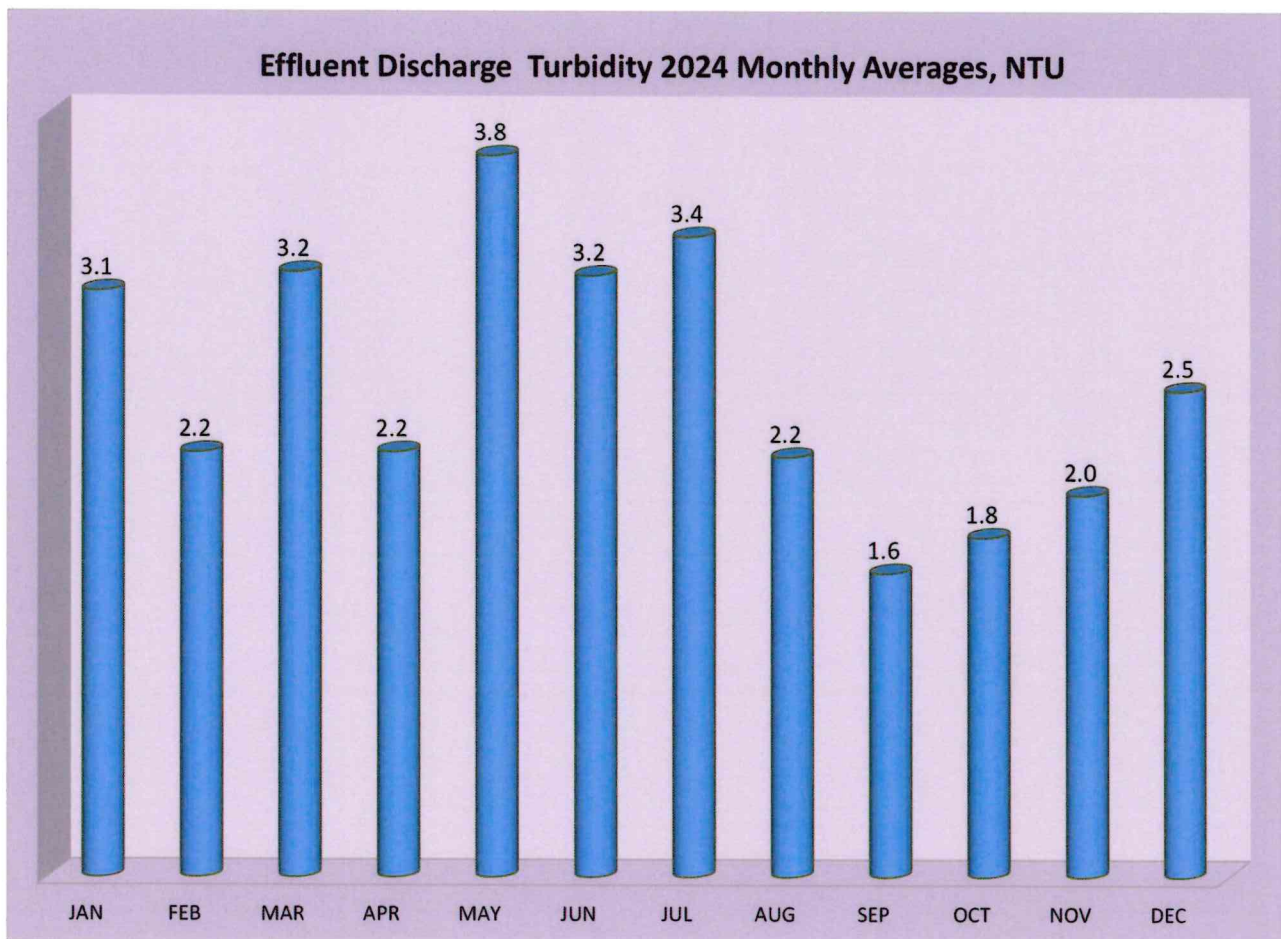
**Figure 2-6. Effluent Discharge Turbidity 2024 Monthly Averages, NTU**

Effluent turbidity was monitored five days per week. The permit limitations for effluent turbidity consists of a monthly average of 75 Nephelometric Turbidity Units (NTU), a weekly average of 100 NTU, and a maximum at any time limitation of 225 NTU. Effluent turbidity data are shown graphically in Figure 2-6. The maximum value at any time, 9.0 NTU, occurred on March 18<sup>th</sup> which was still well below the effluent limits. Monthly averages ranged from a low of 1.6 NTU to a high of 3.8 NTU. All values were significantly below their respective permit limitations.

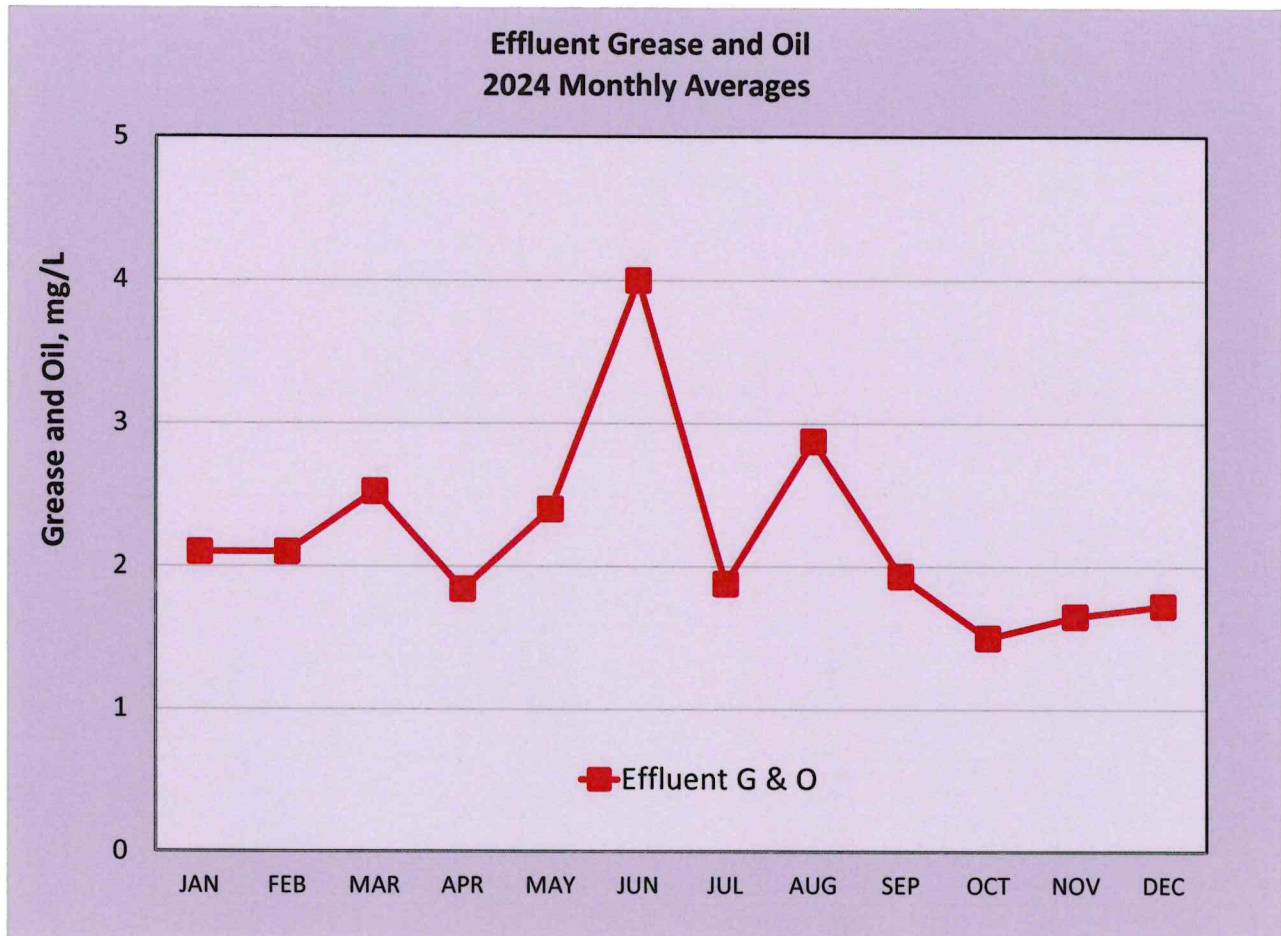
**Figure 2-7. Effluent Grease and Oil 2024 Monthly Averages**

Effluent oil and grease were monitored weekly. Monthly average results are shown graphically in Figure 2-7. Prior to August 2007 Freon was the solvent used in the standard method to extract oil and greases from water samples. According to EPA regulations, in August 2007 the GSD laboratory ceased using Freon as the extraction solvent and began using hexane as the required solvent. The District continued to use the liquid-liquid extraction method, the only change at this time was the solvent. In December 2010, the GSD laboratory began analyzing for oil and grease using the approved standard solid phase extraction (SPE) EPA 1664 method. However, oil and grease samples were also subcontracted to OEC during the year. The current permit, R3-2017-0021, eliminated the influent oil and grease monitoring requirement.

Effluent grease and oil concentrations were low during 2024. All monthly, weekly, and maximum permit limits were met. Mass emissions values ranged from a monthly average low of 56.4 lbs/day in July to a high of 139 lbs/day in June. Both are well below the permit limitation of 1,590 lbs/day. Monthly average oil and grease concentrations in the effluent ranged from 1.5 mg/L to 4.0 mg/L. See Table 2-2 for a visual representation of the monthly average results. All permit limitations for effluent oil and grease were met during 2024.

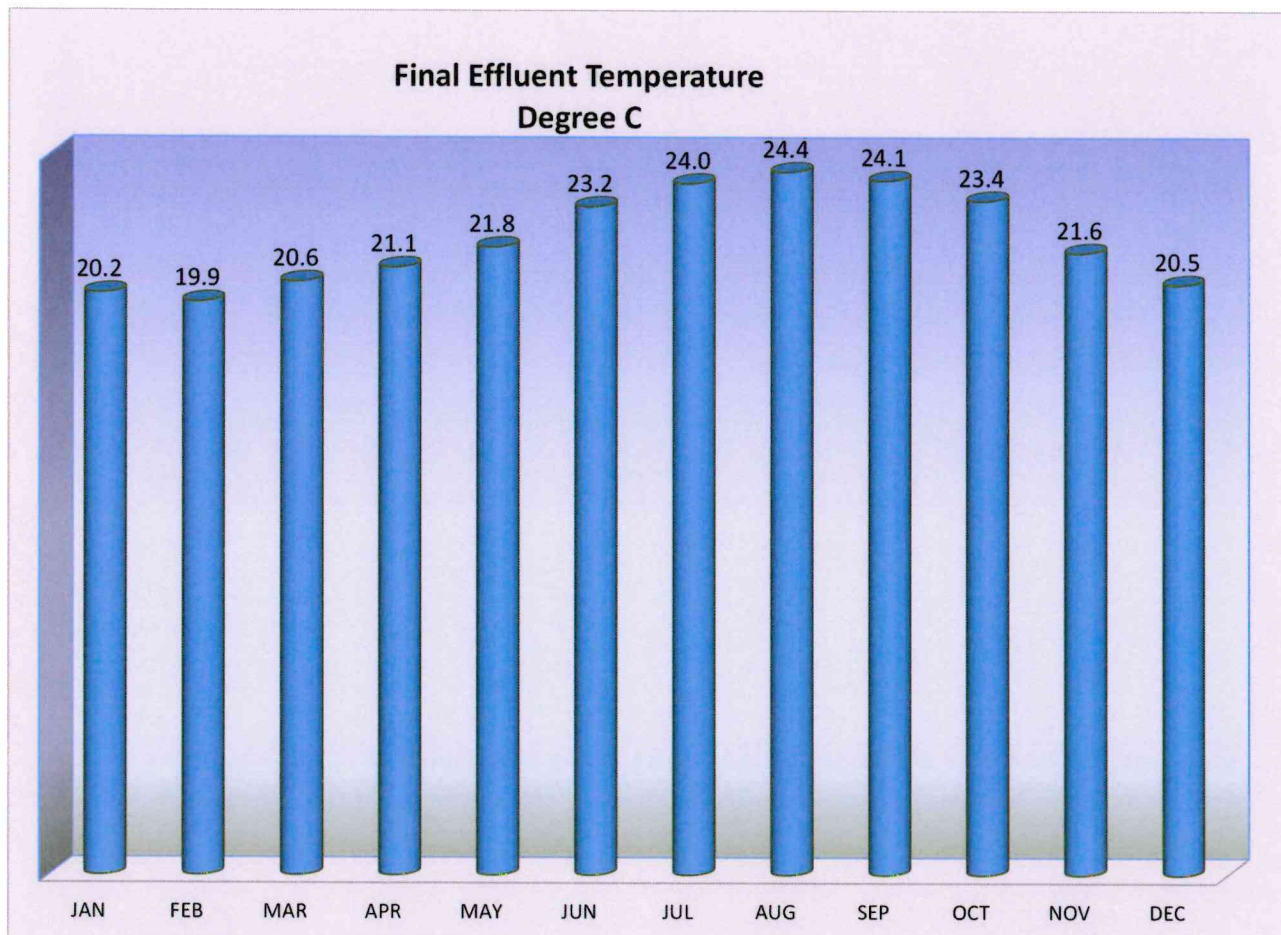
**Figure 2-8. Effluent Discharge Temperature 2024 Monthly Averages**

Effluent temperature was sampled five days per week throughout 2024. The data reflect a typical response to seasonal changes (Figure 2-8). The coolest temperatures occurred during February with average monthly temperatures of 19.9 ° C. A warming trend continued throughout the summer and fall months to reach a monthly averaged high of 24.4 ° C in August. The year began with the coolest average temperatures and ended with a cooling trend.
