GOLETA SANITARY DISTRICT

Climate Adaptation Plan

Prepared for
Goleta Sanitary District

June 2022

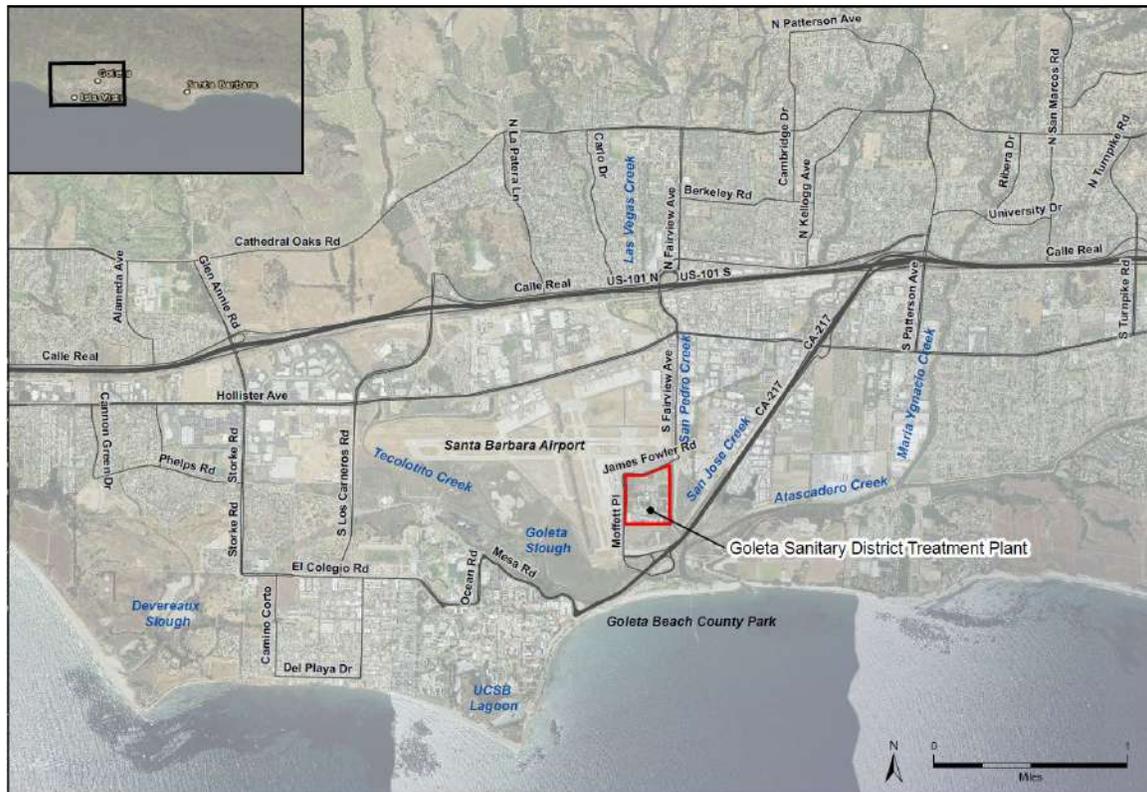
Figure 1
Project Location and Vicinity Map

The District's Water Resource Recovery Facility (WRRF) is located approximately 2,300 feet from the Pacific Ocean shoreline in Goleta, California and is situated on the northern face of Mescalitan Island within Goleta Slough (**Figure 1**). The watershed that drains into Goleta Slough is about 45 square miles and includes the drainages of seven creeks: Atascadero, Carneros, Las Vegas, Maria Ygnacia, San Jose, San Pedro and Tecolotito Creeks. Goleta Slough has experienced several large flood events over the past century, including major floods which forced the closure of the Santa Barbara Airport in 1969 and 1995. As the climate changes and sea levels rise, the risk of flooding and other adverse impacts to District infrastructure due to elevated water levels within Goleta Slough will increase.

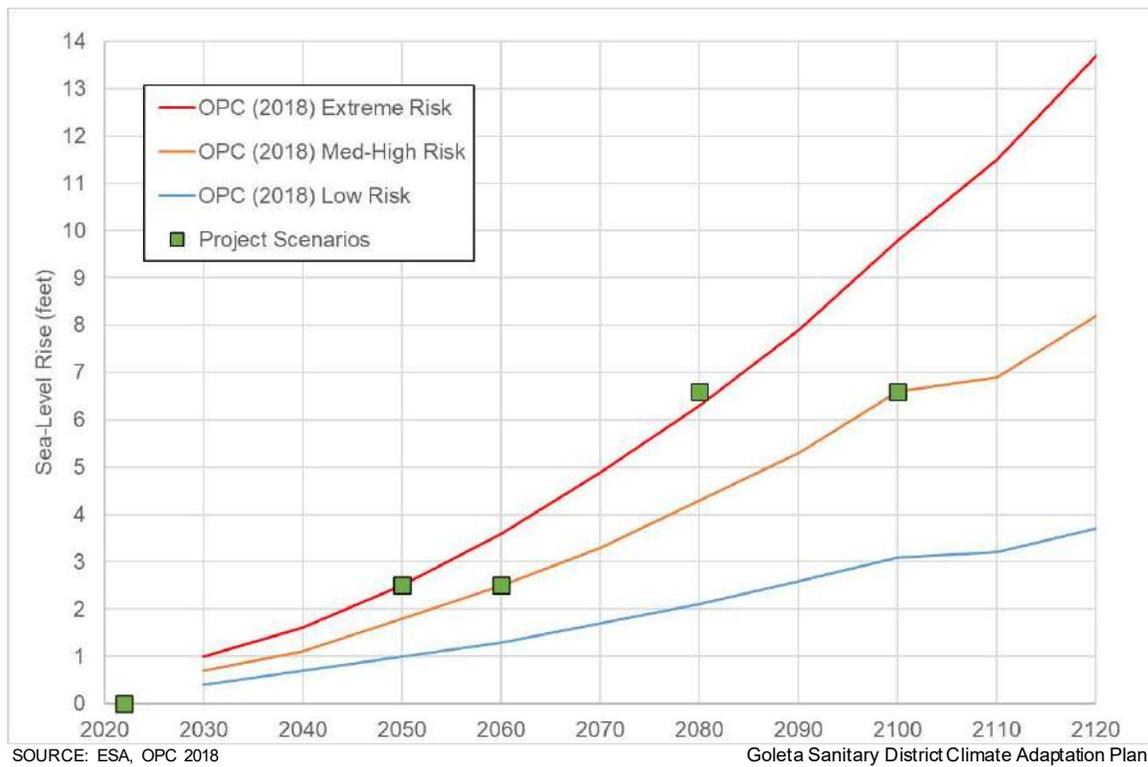
Figure 2
Sea Level Rise Projections for Santa Barbara Area with Project Scenarios

Figure 2 presents a chart of the sea level rise projections based on the CA OPC (2018) guidance. Although the publicly available hazard maps were not evaluated at the exact sea level rise amounts of OPC (2018) tabulated in Table 1, they are representative of the new guidance within a reasonable amount of uncertainty.

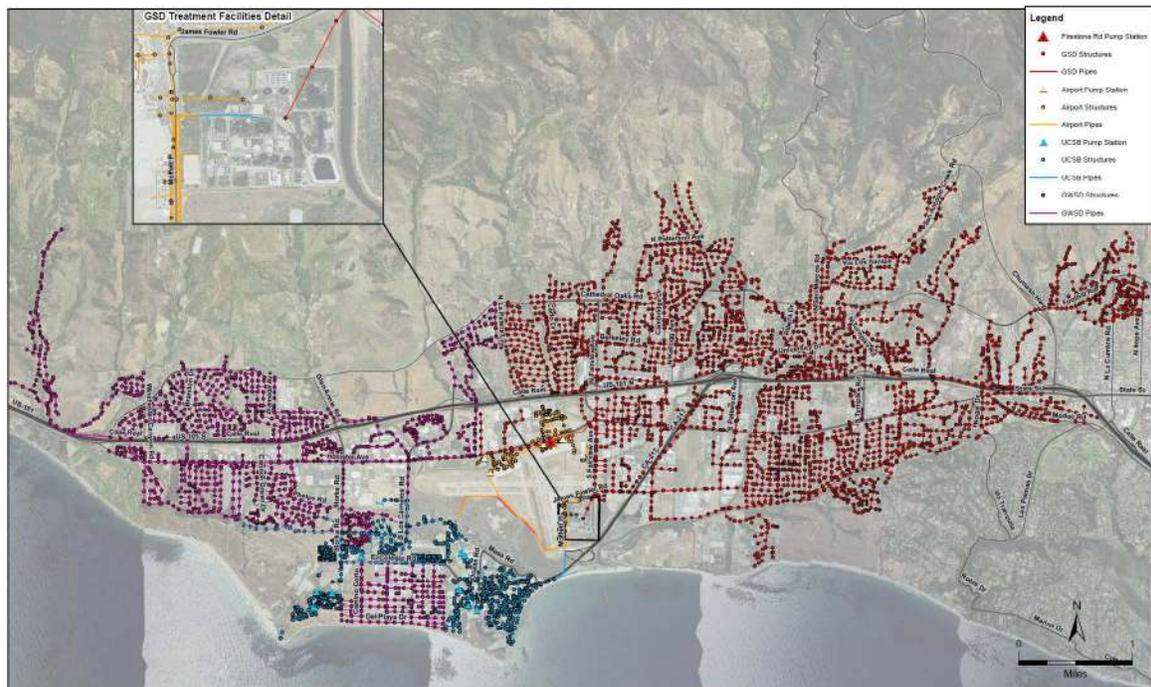
Figure 3
Wastewater Assets

District wastewater assets include manholes, cleanouts, junction boxes, and drop structures (collectively referred to as structures), pumps, pipes and other wastewater collection and treatment facilities. Georeferenced asset data were obtained by MNS from the various jurisdictions that convey wastewater District treatment facilities. These data were used along with the hazard data in GIS to create asset exposure maps and tabulate exposed assets by hazard and sea level rise scenario (see Section 5). **Figure 3** shows the extents of wastewater assets that flow to the District.

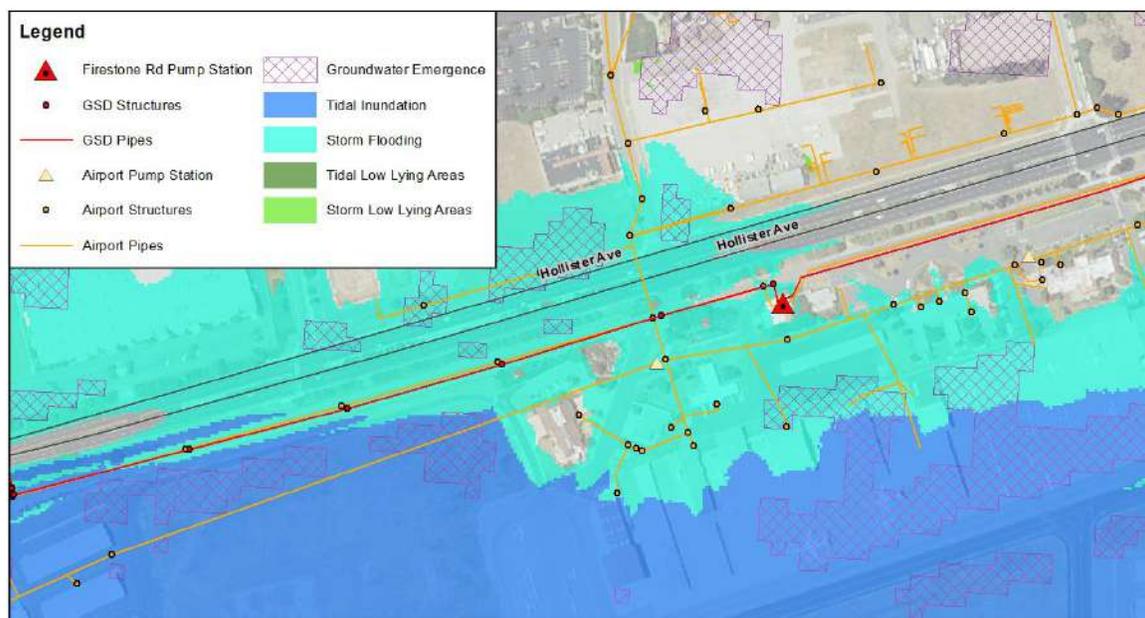
Figure 4
Firestone Road Pump Station Coastal Flooding Exposure
with 6.6 Feet Sea Level Rise

The Firestone Road lift station is potentially exposed to coastal storm flooding with 6.6 feet sea level rise. The pump house itself is not within the coastal flood hazard zone but Firestone Road and the area surrounding the pump house is shown as flooded by the 100-year coastal storm (see **Figure 4**). Other roads are exposed to coastal storm flooding that provide access to the WRRF from the north: South Fairview Avenue near Hollister Avenue and James Fowler Road near the Santa Barbara Airport.

The Firestone Road pump station is within the FEMA 100-year flood zone for precipitation-driven river flooding. Otherwise, access to the pump station may be impaired during extreme (100-year) coastal flooding at the end of the century based on CoSMoS flood mapping for 6.6 feet sea level rise (see **Figure 4**). MNS completed an evaluation of necessary improvements to reduce risks associated with flooding of the Firestone Road Pump Station.

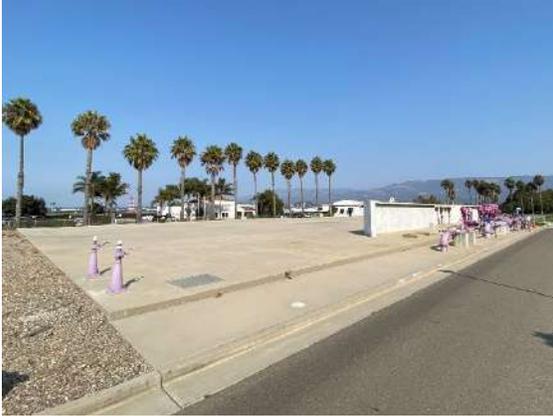
Rising groundwater levels associated with sea level rise in Goleta Slough will increase buoyancy forces on underground facilities such as the recycled water underground storage tank and chlorine contact basin. MNS conducted a simplified buoyancy analysis of the existing below-grade recycled water storage tank and chlorine contact basin based on available record drawings and coastal hazard data for late century (6.6 feet sea level rise and 100-year coastal storm).

Both structures were constructed with extended base slabs to counteract buoyant forces to prevent floatation; however, the assumptions used in sizing these extended slabs are unknown. Geotechnical reports for original construction of the structures were not available for preparation of this analysis. The analysis for both structures includes an assumption of fresh water (non-sea water) groundwater levels up to the grade/ground surface surrounding each structure, with each structure empty. This analysis scenario represents the potential groundwater conditions in the future with 6.6 feet of sea level rise during a 100-year coastal storm event. Groundwater has the potential to rise within 3.3 feet of the ground surface in this location by late century with 6.6 feet sea level rise. During a storm event, saturated soils could be expected to come up to grade on a temporary basis.

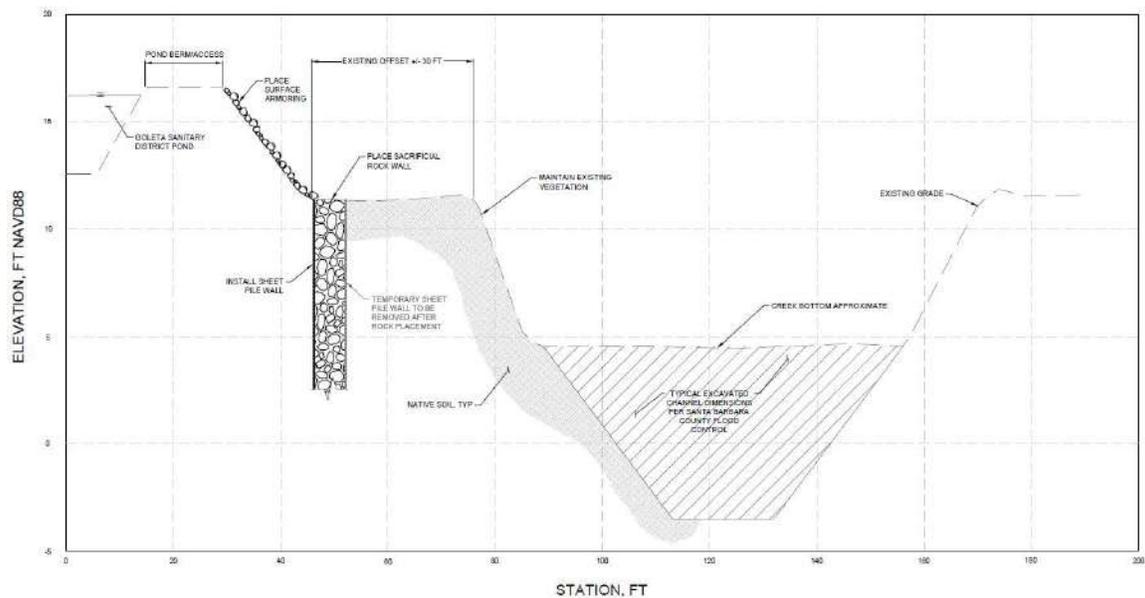
Figure 5
San Pedro Creek bank stabilization conceptual cross section:
Sacrificial Rock Wall

In addition to armoring the outboard pond berm face and installing sheet pile wall along the toe of the berms, this concept utilizes a sacrificial rock wall that is buried in front of the sheet pile wall to be installed at the outboard toe of the pond berms. The concept has less impact to the existing creek bank in its construction methods and ultimate footprint, limiting work area to the top of the terrace between the pond berm and the creek bank. The sacrificial rock wall, when exposed by future creek bank erosion, would slump in place to provide additional erosion resistance and reduce scour at the face of the sheet pile wall. **Figure 5** shows a cross section schematic of this bank stabilization concept. A large format conceptual cross section and opinion of probable construction cost for the Sacrificial Rock Wall concept is provided in **Appendix F**.

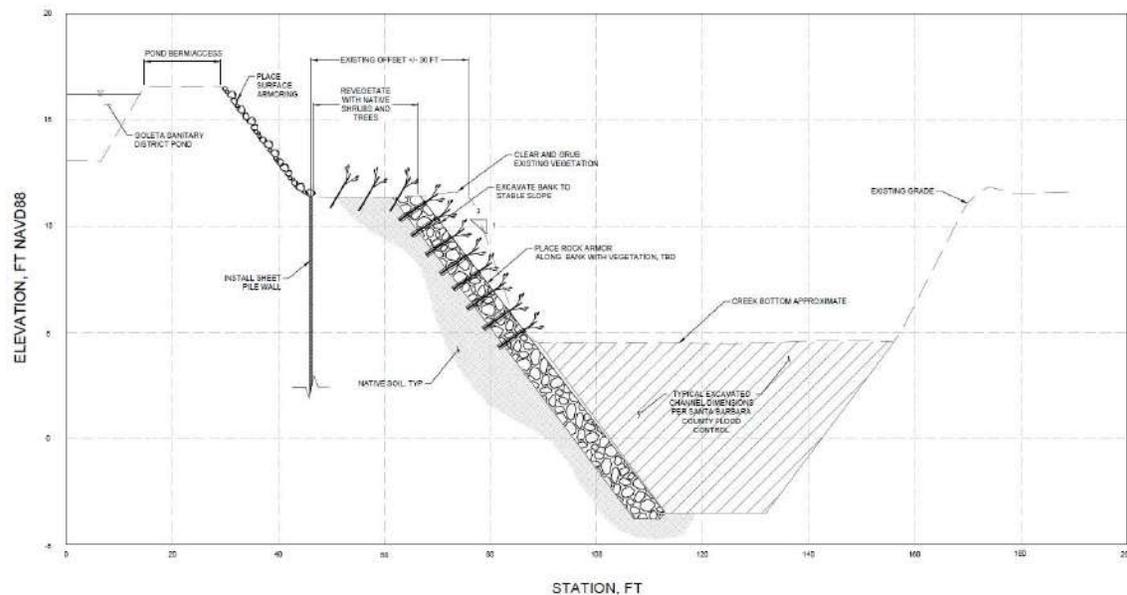
Figure 6
San Pedro Creek bank stabilization conceptual cross section:
Vegetated Rock Slope Protection

In addition to armoring the outboard pond berm face and installing sheet pile wall along the toe of the berms, this concept utilizes vegetated rock slope protection constructed along the creek bank. The concept includes removing existing vegetation from the creek bank, grading the bank to a stable slope and exporting material, placing rock slope protection that is planted with willows and/or big salt brush and irrigated for 5 years during summer. **Figure 6** shows a cross section schematic of this bank stabilization concept. The lower limit of rock armoring on the creek bank is based on typical sediment removal dimensions shown in recent dredging drawings provided by

Since willows were observed at these two nearby reference sites, the arroyo willow species may be appropriate for the more extensive bank stabilization concept with vegetated rock armoring (**Figure 6**). Recent literature suggests that willows have some salt tolerance (Ferrus-Garcia et al. 2002; Hangs et al. 2011); however, we recommend further investigation of soil and water salinity at the District property and reference sites to determine the viability of willows. A combination of willows (for stabilization and visual barrier) and big saltbrush (for stabilization) may be an appropriate vegetation makeup for the vegetated rock slope protection element. If further study

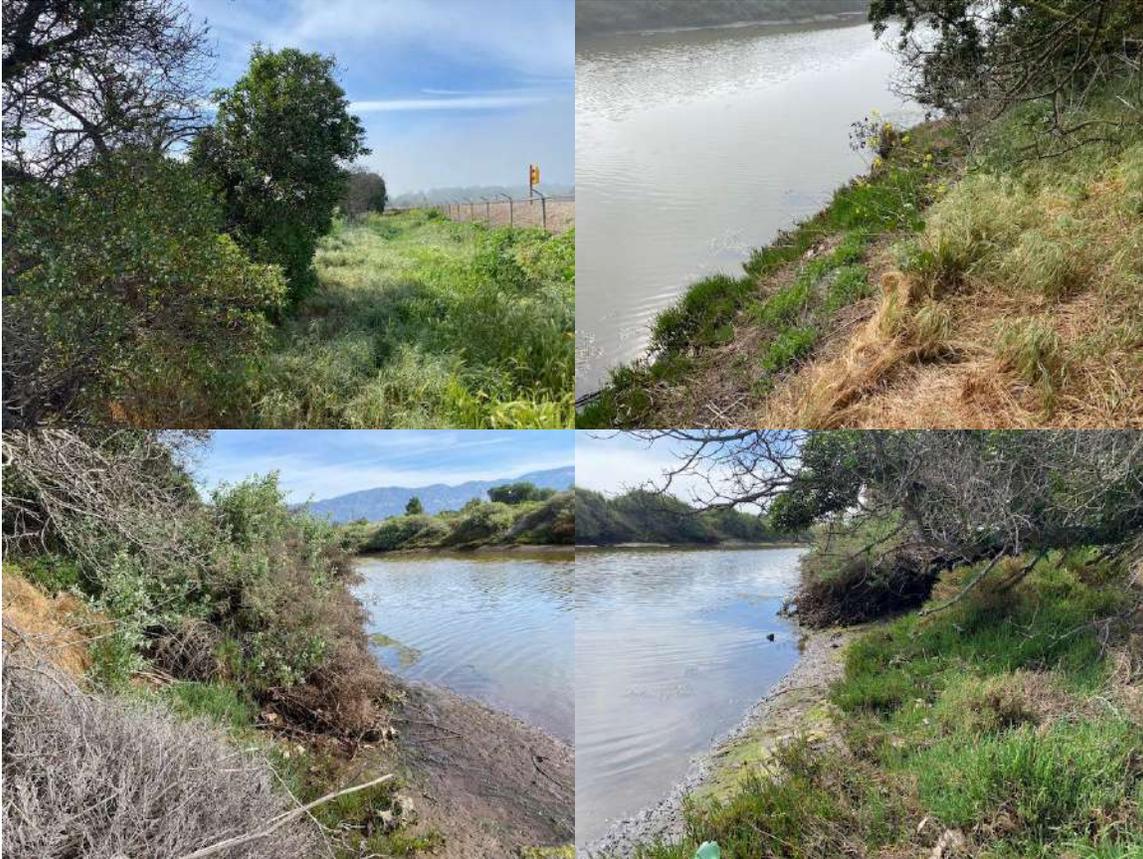
To better understand what vegetation species may be utilized in this concept, ESA assessed the existing conditions of the creek bank including vegetation makeup along the bank at District property and two nearby reference sites during a site visit on March 25, 2022. The existing creek bank vegetation along the District property includes the mousehole tree (*Myoporum laetum*, an invasive), quailbrush or big salt brush (*Atriplex lentiformis*), one non-native tuna cactus (*Opuntia ficus-indica*), and pickleweed (*Salicornia* sp.) at the bank toe. **Figure 7** shows photos taken along the creek bank adjacent to the District ponds. Note that the bank appears steep but was vegetated for the areas that could be accessed.

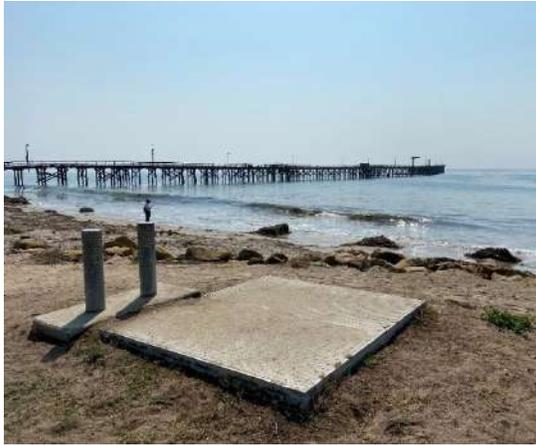
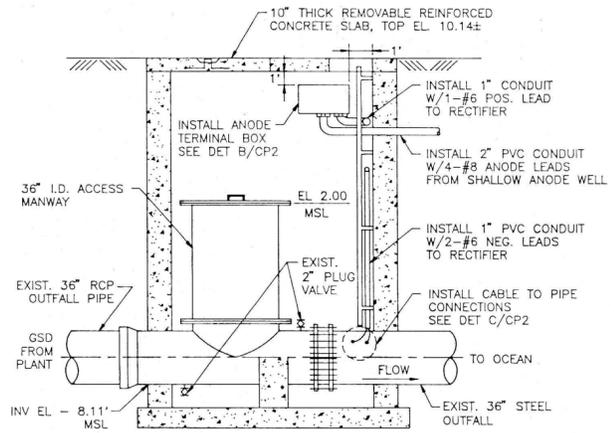
Figure 8
Beach Access Vault Photo (ESA 2021) and Cross Section
(Brown and Caldwell 1994)

The outfall pipe access vault at Goleta Beach (**Figure 8**) is subject to coastal storm wave run-up under existing conditions and may be exposed to coastal erosion by the end of this century based on USGS CoSMoS projections for 6.6 feet sea level rise. Recent impacts to the outfall have occurred resulting in repairs, suggesting that the outfall access vault and pipe may become exposed to coastal erosion and wave run-up sooner than indicated by CoSMoS projections. Potential adaptation strategies may include removing the access vault. The District currently has an initial adaptation plan to remove and/or abandon the maintenance vault when needed (S. Wagner, District, personal communication, June 1, 2021). The outfall pipe landward of the vault could be stabilized and protected by installing joint restraints and or armoring the pipe (e.g., with reinforced concrete or other armoring) to protect against potential erosive forces from waves with future sea level rise.

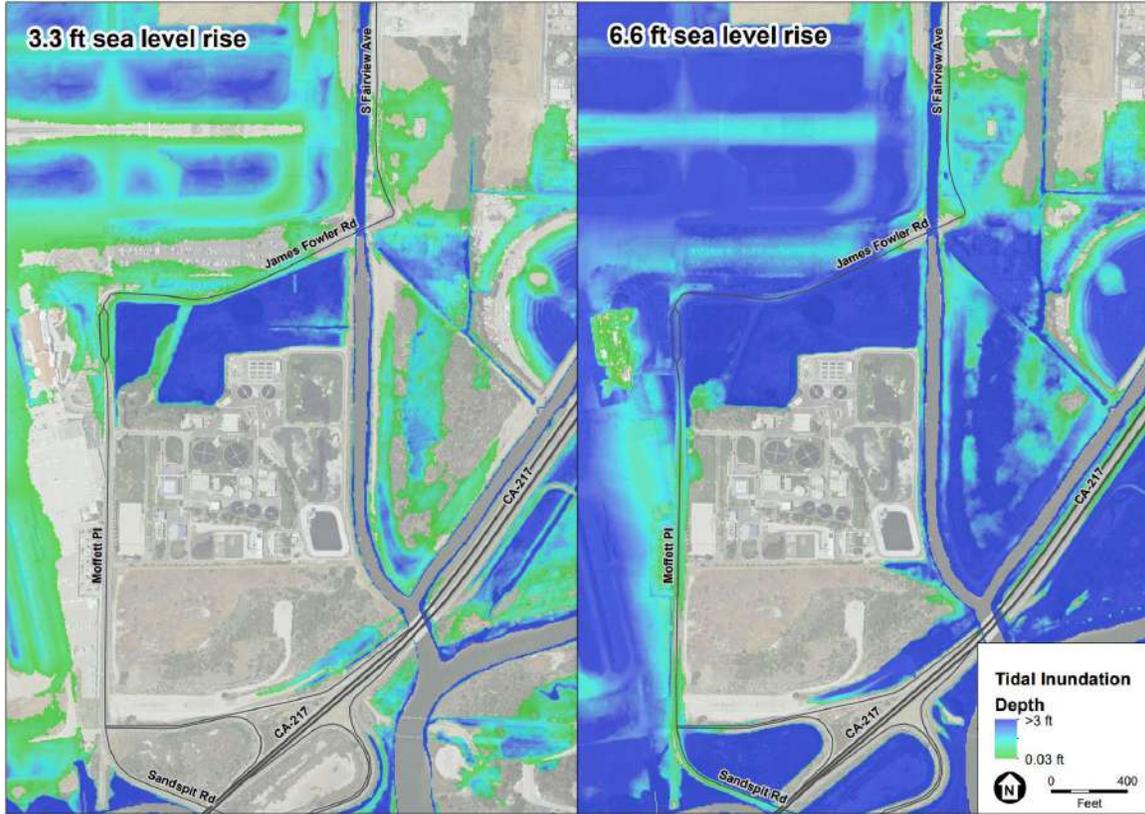
Storm flooding in Goleta Slough may impair access to the District's WRRF for hours or days during an extreme event today based on USGS CoSMoS maps for coastal flooding and FEMA maps for fluvial flooding. Access to the WRRF is also impaired by estuarine flooding with 2.5 or more feet sea level rise. While sea level rise may lead to more extensive storm flooding events in the future, it will also lead to more frequent inundation of low-lying roadways during normal tidal conditions. **Figure 9** shows tidal inundation depths along Moffat Place and S James Fowler Road with 3.3 feet and 6.6 feet of sea level rise. Access to the WRRF may be impaired by regular tidal inundation with 3.3 feet of sea level rise. James Fowler Road may flood 10 inches to 14 inches during regular high tides with 3.3 feet of sea level rise. Flood depth during regular high tides increases to 3.3 feet deep with 6.6 feet of sea level rise. South Fairview Avenue will similarly flood 2 inches to 1.6 feet during high tides with 3.3 feet to 6.6 feet of sea level rise, respectively. Sea level rise planning should be coordinated with City of Santa Barbara, City of Goleta, Santa Barbara Airport and Santa Barbara County on raising these roads above future tidal inundation levels at a minimum. This adaptation measure may be addressed in coordination with other adaptation in Goleta Slough (e.g., Santa Barbara Airport).

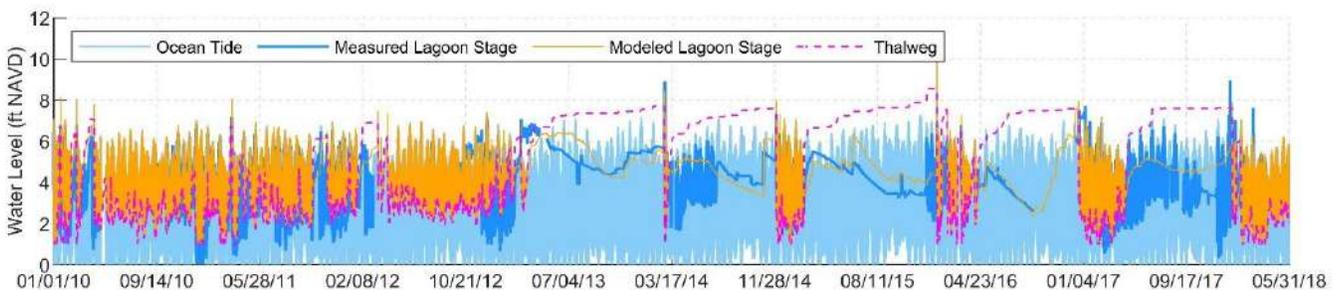
Figure 1: QCM model results of Case 1 (0 feet SLR, existing breaching)

Case 1 is intended to be a hindcast of observations in the lagoon to understand the sensitivity of the lagoon to coastal and fluvial conditions, and to provide an understanding of the level of uncertainty in model predictions. The model hindcast for this period is described more extensively in prior work by ESA PWA (2015). Generally, the model captures the seasonality of mouth closure behavior and seasonal water levels caused by transitions between mouth open and closed periods, although at the daily or hourly scale, it does not capture all events. For Case 1 (0 feet SLR, existing breaching, Figure 1) the model predicts five long-term (order of several months to a few years) mouth closure events, which aligns with measurements of lagoon water levels. Interestingly, for this case the highest lagoon water levels and thalweg elevations occur at the end of closure events right before the onset of the breaching events. This is not uncommon in coastal lagoons in California, and results from the fact that the beach is typically highest after several months of mouth closure, meaning that the highest water levels that are often observed occur at the time that the lagoon has filled sufficiently with trapped freshwater input behind the closed beach to the level that it can overtop the beach and erode a new mouth.

Lagoon hydrology and morphology at Goleta Slough were simulated for 8 years using lagoon water level data previously provided to ESA and nearshore wave conditions (10 m water depth) provided by CDIP from 2010 to 2018. Figures 1 through 5 show the simulation results of cases 1 through 5 (see Table 1). The lowest and highest levels of ocean tides, and simulated lagoon water levels and thalweg elevations are reported in Table 2.

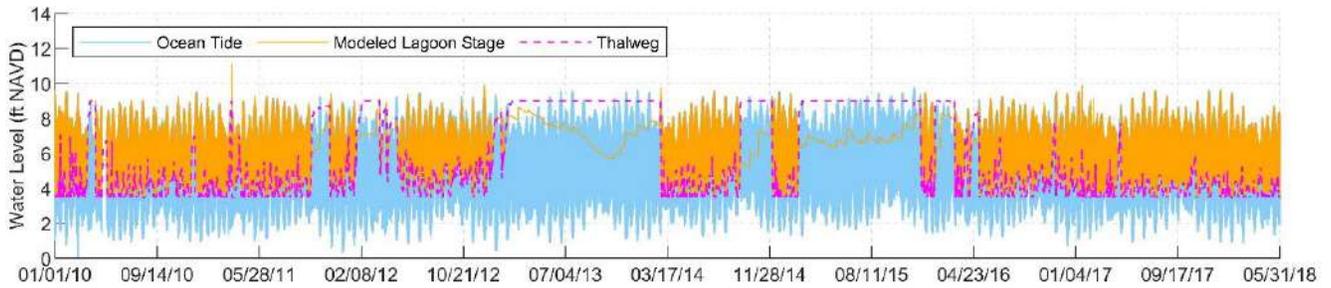
Figure 2: QCM model results of Case 2 (2.5 feet SLR, existing breaching)

For Case 2 (2.5 feet SLR, existing breaching, Figure 2) two long-term mouth closure events are predicted between late 2012 and early 2014 and between early 2015 and late 2015, which are concurrent with the closure events of Case 1 (Figure 1). Comparison of Case 1 (0 feet SLR) and Case 2 (2.5 feet SLR) shows that the lagoon water levels and thalweg heights are higher in Case 2 which indicates that lagoon adapts itself with SLR of 2.5 feet based on the model results. Interestingly, results of 6.6 feet SLR (Case 3) predicts the lagoon to be open during the entire simulation interval based on the existing breaching (thalweg elevation limited to 9 feet above NAVD 88) with the tidal elevations having the highest levels compared with the lagoon water levels and thalweg elevations. Moreover, for this case the peak values of lagoon water levels (13.4 feet above NAVD88) are close to those of ocean tides (14 feet above NAVD88) indicating that lagoon water levels increase with sea level rise.

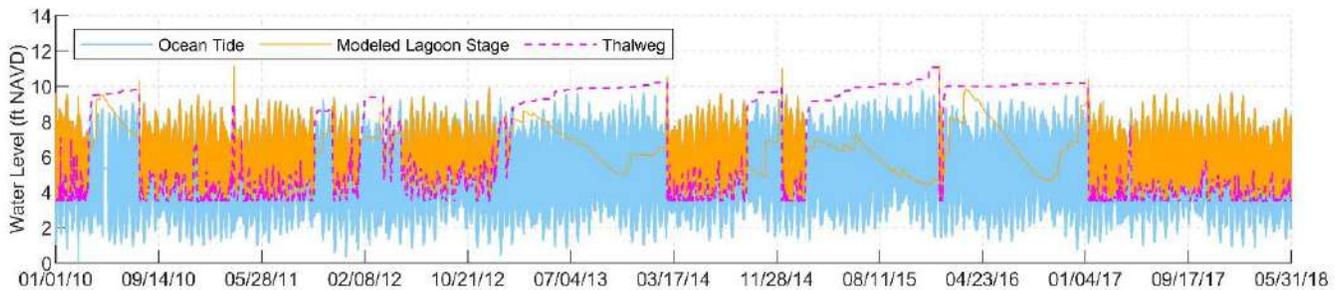
Figure 4: QCM model results of Case 4 (2.5 feet SLR, adaptive breaching)

In the case of adaptive breaching under 2.5 feet SLR (Case 4, Figure 4), three long-term mouth closure events were predicted by the model, where the first closure is concurrent with the closure predicted for Case 2 (between late

2012 and early 2014). As expected the maximum thalweg elevation for adaptive breaching Case 4 (11.05 feet above NAVD88) was higher than the value predicted for existing breaching Case 2 (9 feet above NAVD88). Furthermore, in Case 4 the lagoon water levels peak higher than 10 feet above NAVD at the onset of breaching events where lagoon water levels are mainly below 10 feet in Case 2. However, model prediction of maximum lagoon water levels are very close for Case 2 and Case 4 (11.15-11.2 above NAVD88). Comparison of the existing and adaptive breaching strategies under 2.5 feet SLR (Cases 2 and 4) further indicates that the adaptive breaching might be more cost-effective since the lagoon water levels are in similar ranges (peaks mainly between 8 and 10 feet above NAVD88) for both cases. Model results found to have a higher sensitivity to the breaching strategies under 6.6 feet SLR (compare Figure 3 and Figure 5). For adaptive breaching under 6.6 feet SLR (Case 5, Figure 5) model predicts a five-year mouth closure event between 2012 and 2017 which was not predicted for existing breaching (Case 3, Figure 3). Accordingly, the maximum thalweg elevation for the adaptive breaching (Figure 5) was calculated as 15.2 feet above NAVD88 which is significantly higher than the maximum thalweg elevation of 9 feet for existing breaching (Figure 3) under 6.6 feet SLR. The maximum lagoon water level under 6.6 SLR with adaptive breaching (Figure 5) was predicted as 15.2 feet above NAVD88 occurring at the end of the 5-year closure event which is higher than the maximum lagoon water level predicted for existing breaching as 13.4 feet above NAVD88 (Figure 3). For these cases model results further indicate that lagoon mouth opening can mitigate the lagoon flood level as differences between the level of ocean tides and lagoon water levels are significantly higher with adaptive breaching during the mouth closure (up to about 7.6 feet between 2012 and 2017, Figure 5) compared to those with existing breaching during the mouth opening (up to about 2.5 feet between 2012 and 2015, Figure 3).
